Avenues of Honour - Tree Management Study

Moyne Shire Council

FINAL REPORT

MARCH 2017

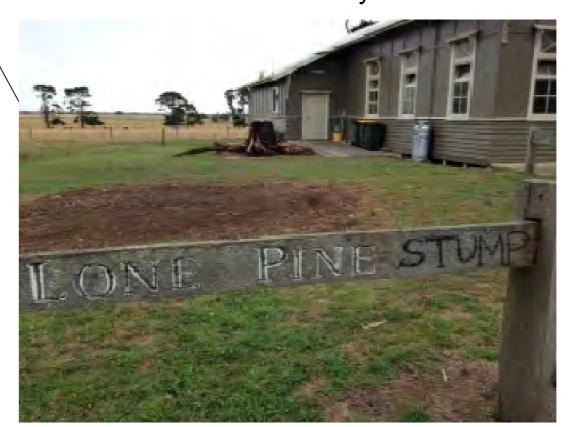
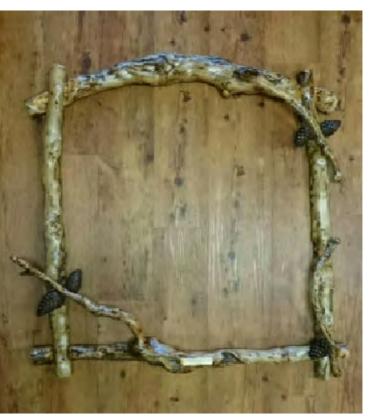
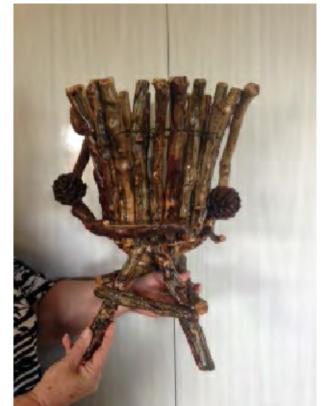
The Lone Pine after it fell in 2016 and some objects it was made into - a rustic frame and seat

A key feature within the community hall's precinct was the Lone Pine (Pinus brutia), which was reputedly sourced from the original Lone Pine at Gallipoli. The Lone Pine fell on the 12th of July 2016 due to a windstorm. The tree was cut into long lengths (as long as possible that could be still be transported). The smaller branches were removed and taken away. The pine cones were collected for their seeds, and they could also be made into momentos. The wood from the tree has since been made into a seat, furniture and a rustic frame. The stump has been removed and is placed on a concrete pad next to the hall.
