EAST BEACH SEAWALL

WORKS PREPARATION

SEAWALL ASSESSMENT & DESIGN CONCEPTS

Moyne Shire Council

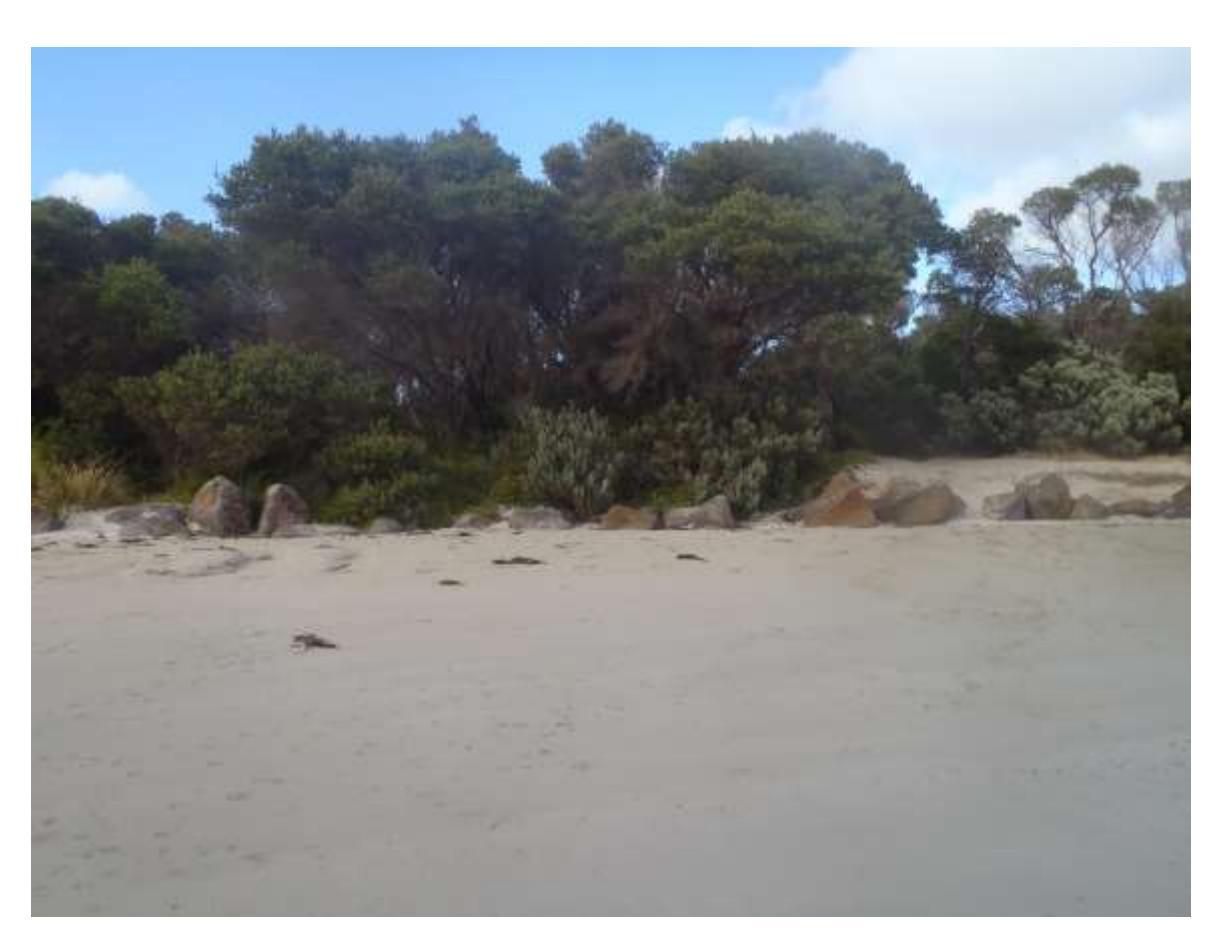
Figure 9 : Typical seawall for Section 1 to 3

Nevertheless should the predicted future sea level rise of 0.8 metres occur by the year 2100, it is expected that the offshore structure will provide a much reduced benefit; and that the seawall would be breeched with a possible breakthrough to the Moyne River if the wall was left in its present condition.

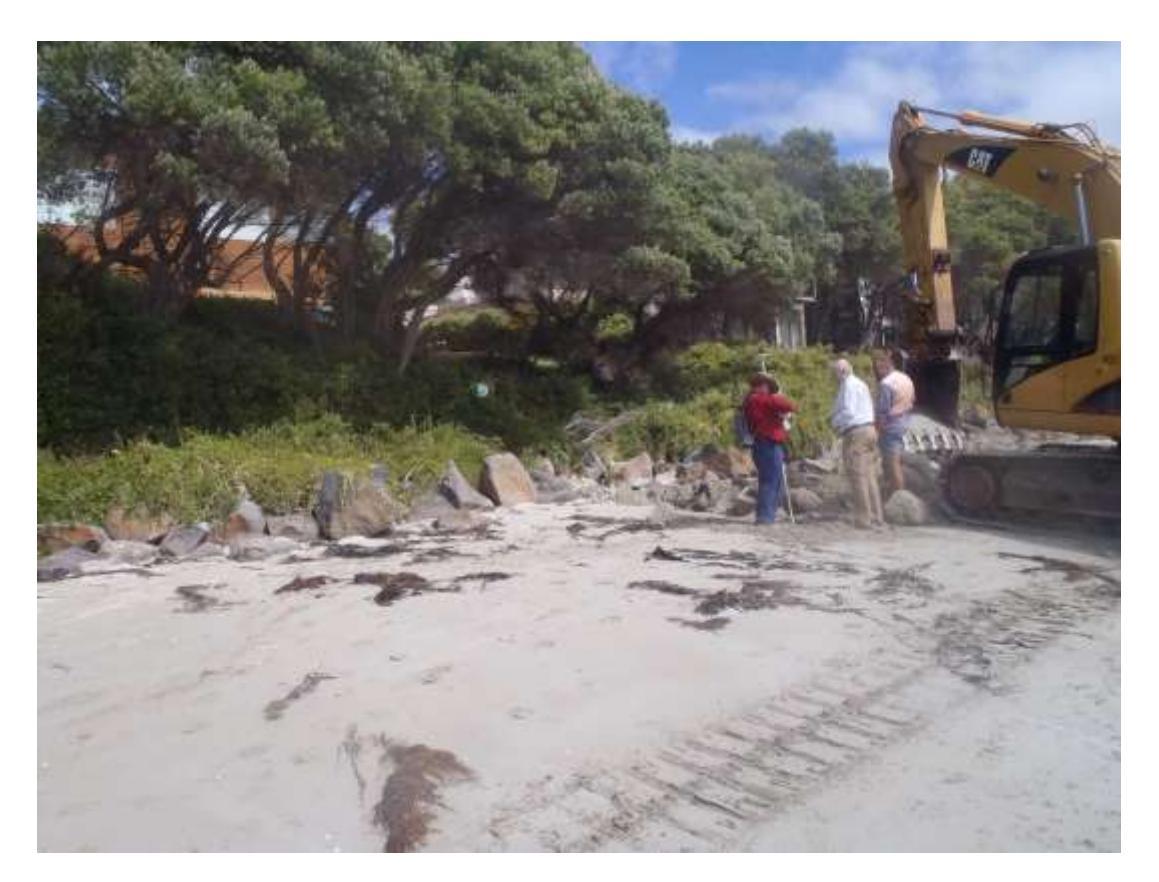
Figure 10 : Seawall at Section 5

All of the rocks are loosely packed along this section of the seawall. The total mass of rock located seaward of the fence line is estimated to be about 800 tonnes along the 175 metre length of foreshore represented by Sections 4 to 6.

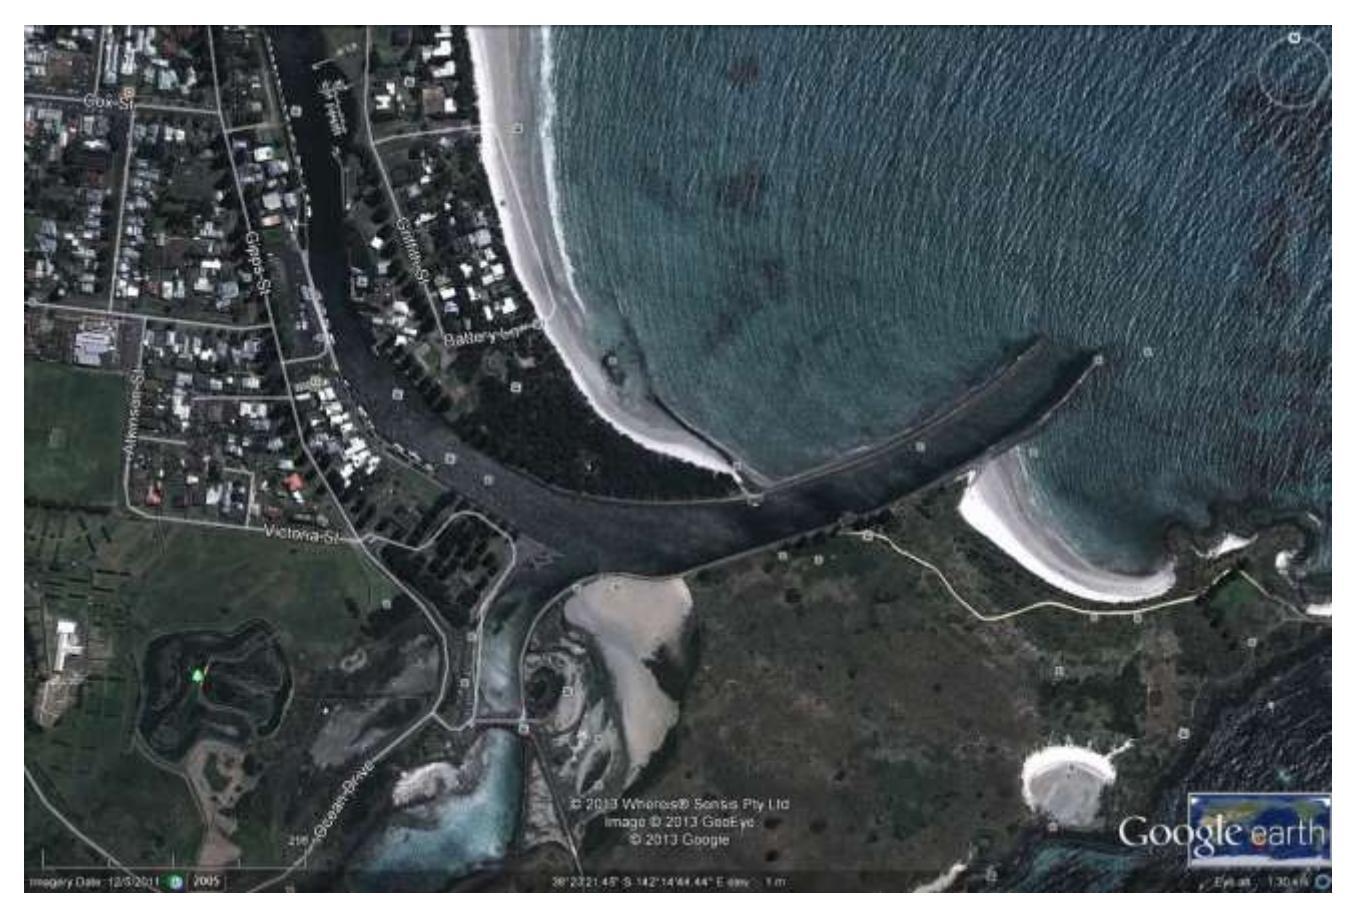
Figure 11 : Aerial photograph showing road seaward of Sections 4 to 6

It is pertinent to note from a Google Earth image of the area (refer to Figure 11) that there was originally a road along the seaward side of existing foreshore buildings. The implication is that the local foreshore eroded some 50 metres following the construction of the Moyne River training walls. It also suggests that this section of the foreshore is vulnerable during large storms, even at present-day sea levels.

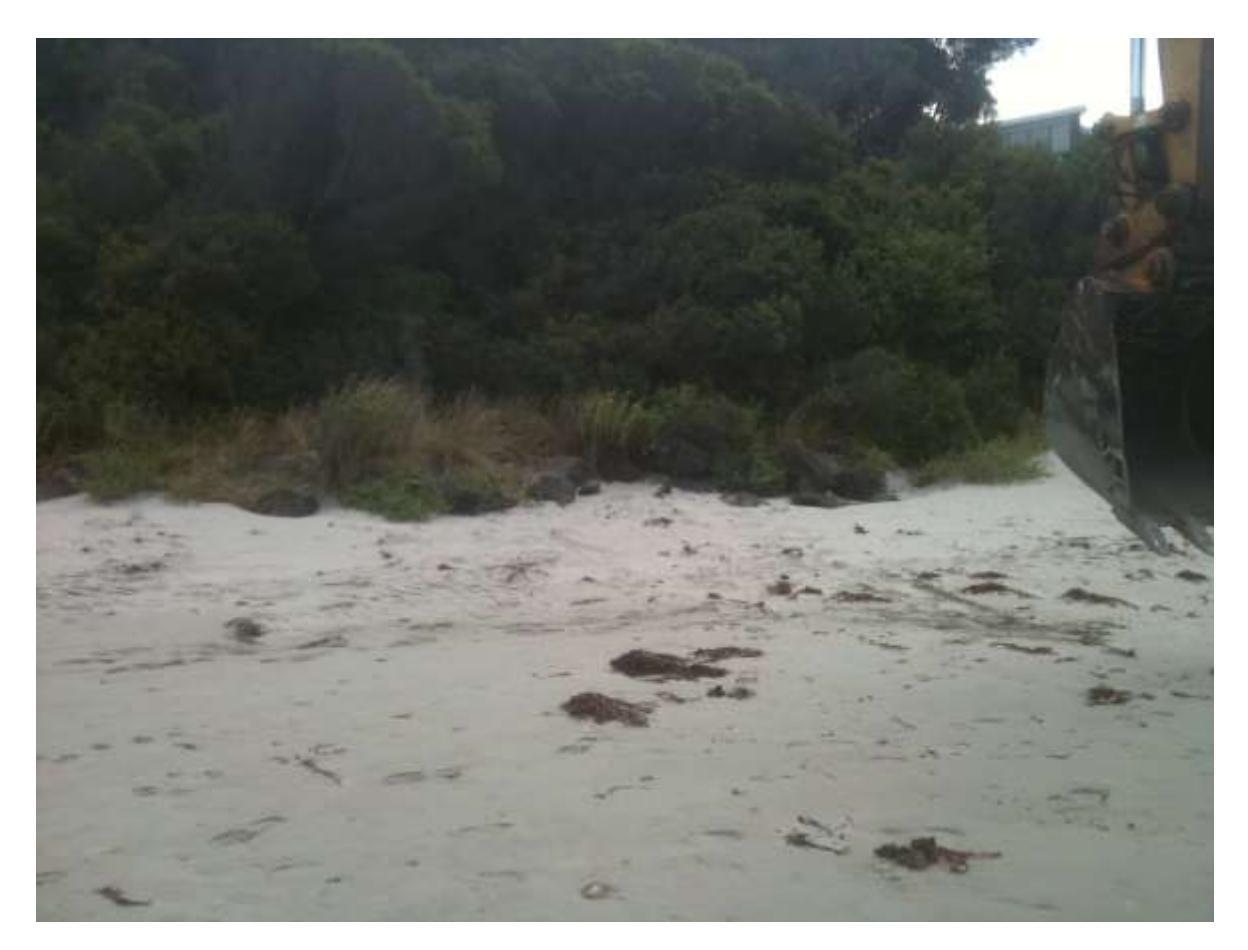
Figure 12 : Seawall at Section 10

As can be seen in Figure 12, the seawall is presently almost completely buried by a low vegetated foredune. The quantity of rock in the seawall is typically about 4.3m³ per linear metre of foreshore. Again the rock armour appears to be loosely placed, and the total quantity of rock in this 470 metre length of seawall is estimated at 3,000 tonne.

Given a predicted sea level rise of 0.8 metres by the year 2100, it is likely that there will not be sufficient sand to allow the dune to naturally reform. Therefore under such a future climate change scenario, waves overtopping the seawall could cause significant erosion of the foreshore and adversely impact on dwellings located behind the seawall.

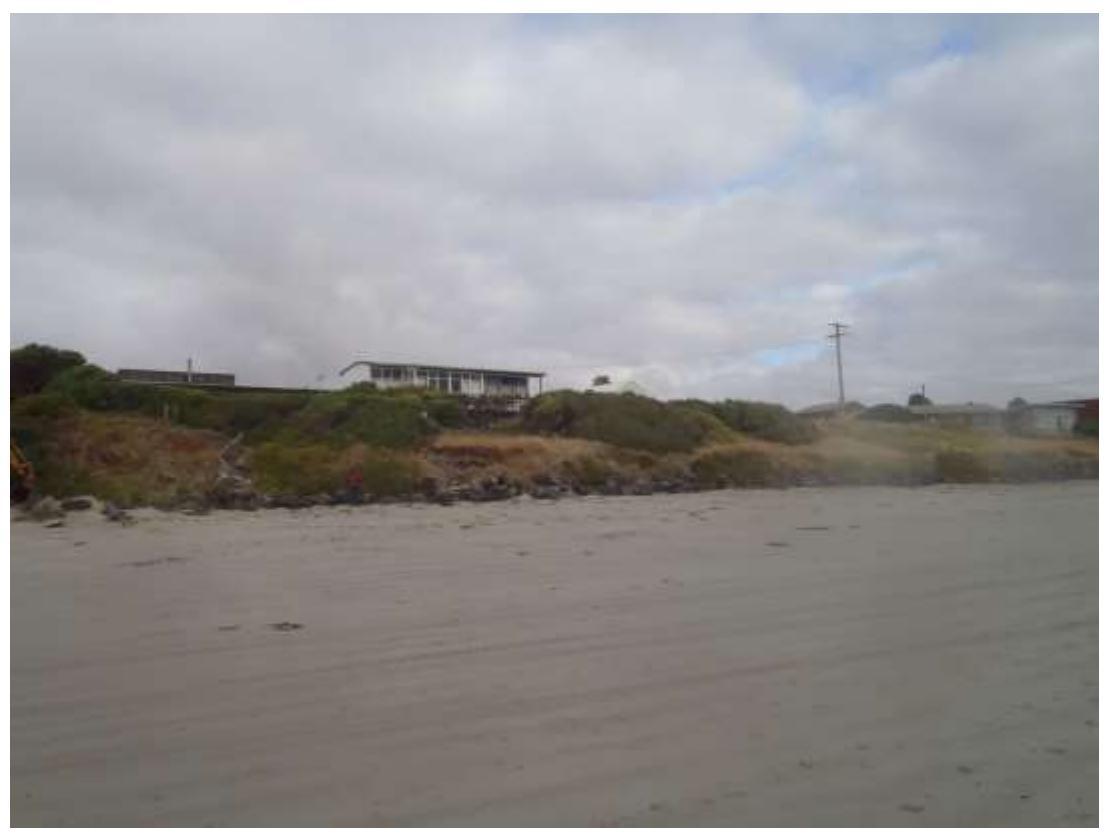
Figure 13 : Seawall between Sections 15 and 16

The top of the seawall is at about +2.5 metres AHD, but the volume of rock in the wall is estimated at only about $4.5m^3$ per linear metre of wall. The toe of the seawall is located about 1.2 metres below the beach level (as illustrated in Figure 14). The beach level is lower than for the foreshore to the south; and the rock appears to be slightly more densely placed. A placing density of $1.6t/m^3$ is estimated, which results in about 700 tonnes of rock within this 100 metre length of foreshore. The type of rock is equally divided between primary armour (of 0.25 tonnes to 2 tonne size) and underlayer rock.

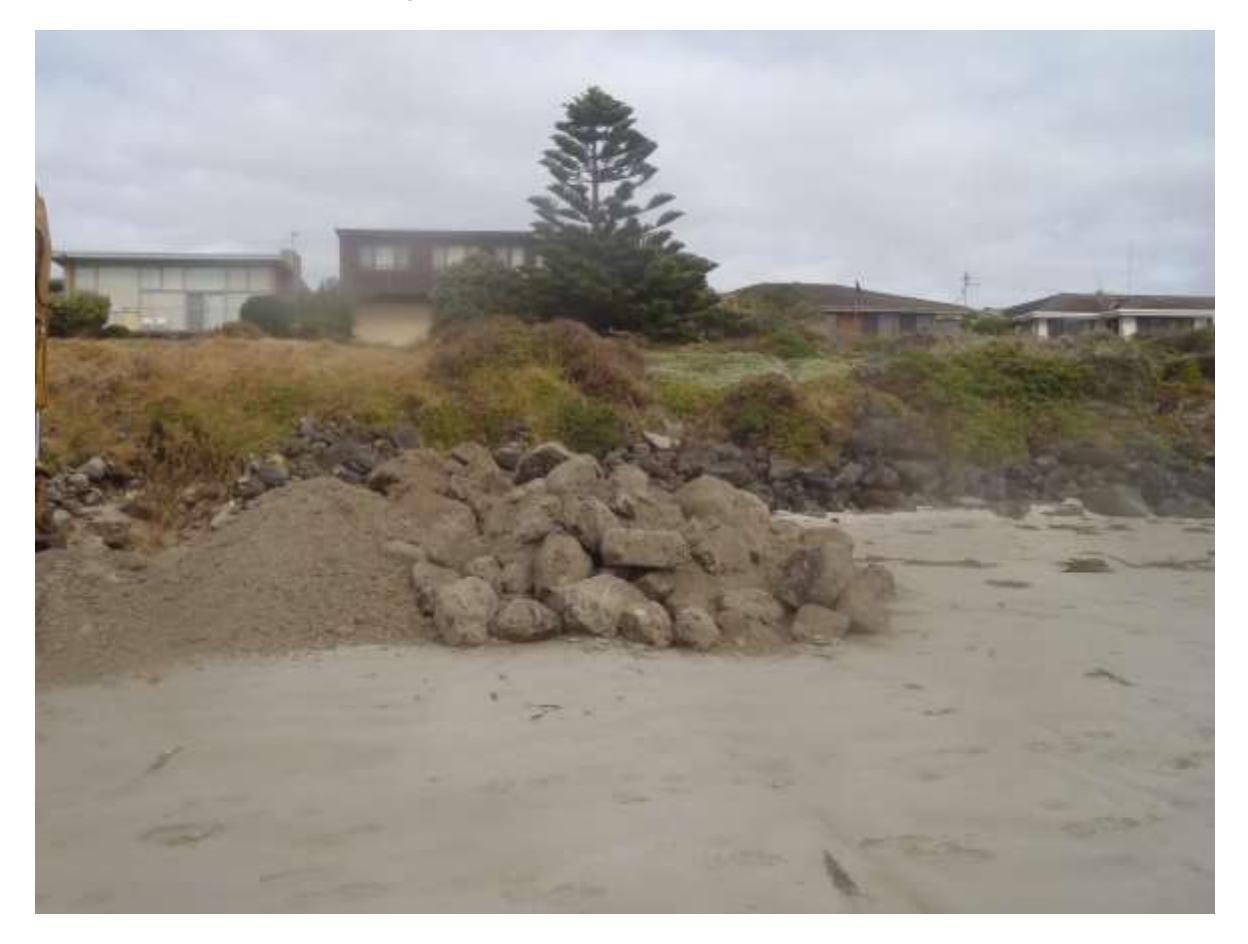
Figure 15 : Typical seawall at Sections 17 to 18 (with excavated rock in foreground)

Excavated cross sections 17 and 18 (having an approximate foreshore length of 120 metres) fall into this category. The crest of the seawall is higher here than it is to the south - with the average crest level being about +3.5 metres AHD. Visually the seawall and embankment are similar to the adjacent Sections 15 and 16. Figure 15 shows the seawall in this area (with the rock excavated from the seawall at Section 17 in the foreground).

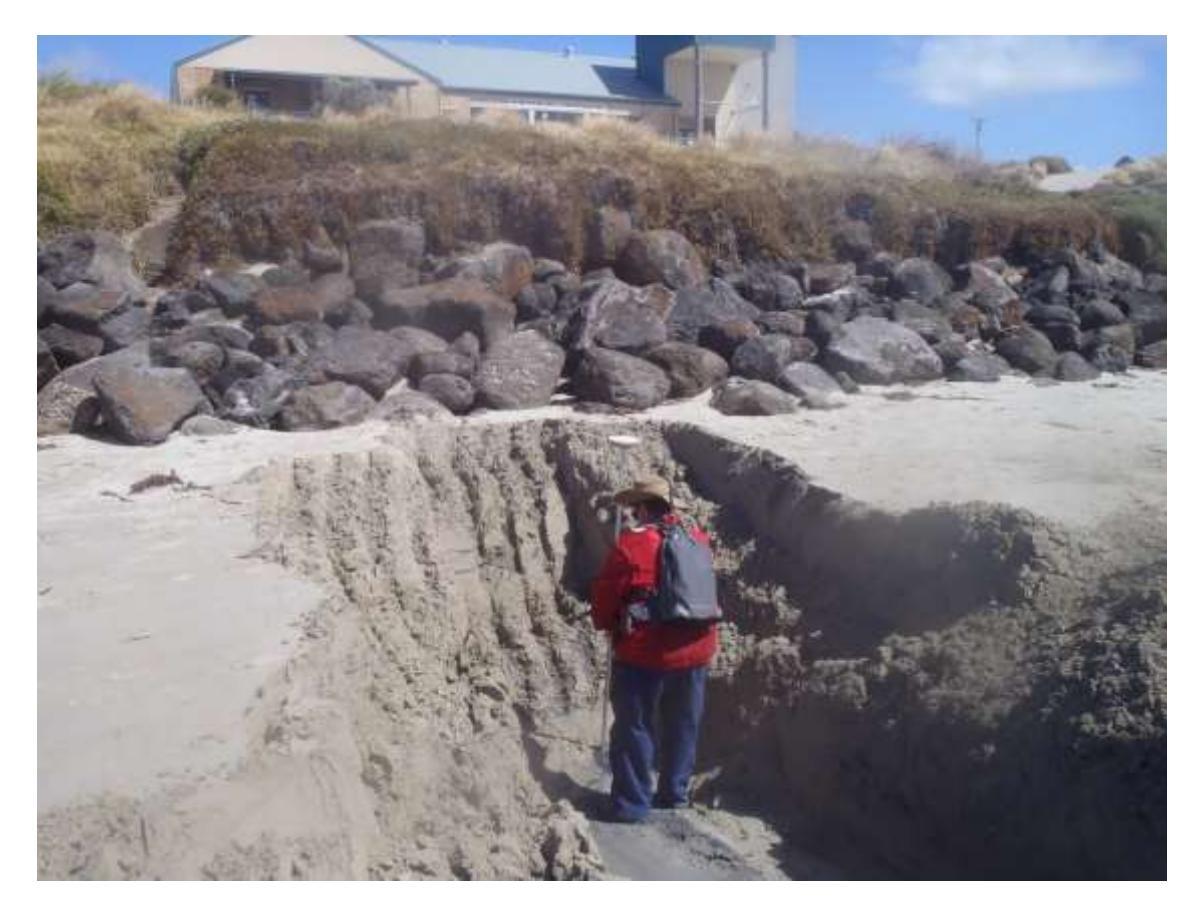
Figure 16 : Seawall at Section 20 (with surveyor standing at the excavated toe of the seawall)

Under the future climate scenario of the year 2100, the wall would sustain substantial structural damage but erosion is not expected to adversely affect the SLSC.

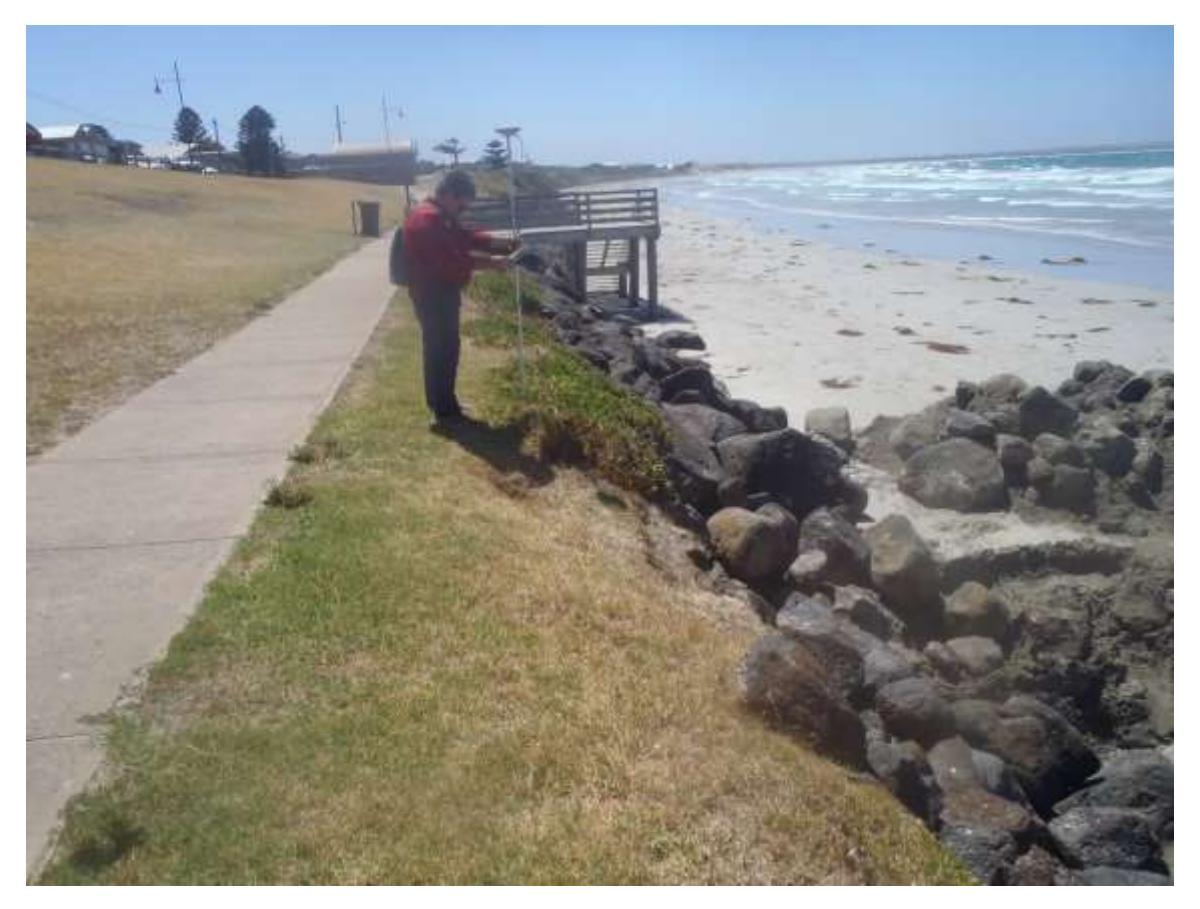
Figure 17 : Seawall from above Section 21 showing proximity of pathway

Given the higher sea level and increased wave energy associated with the year 2100 climate scenario, the pathway would be lost and erosion of the dune could be sufficiently severe as to threaten the parking area behind it.

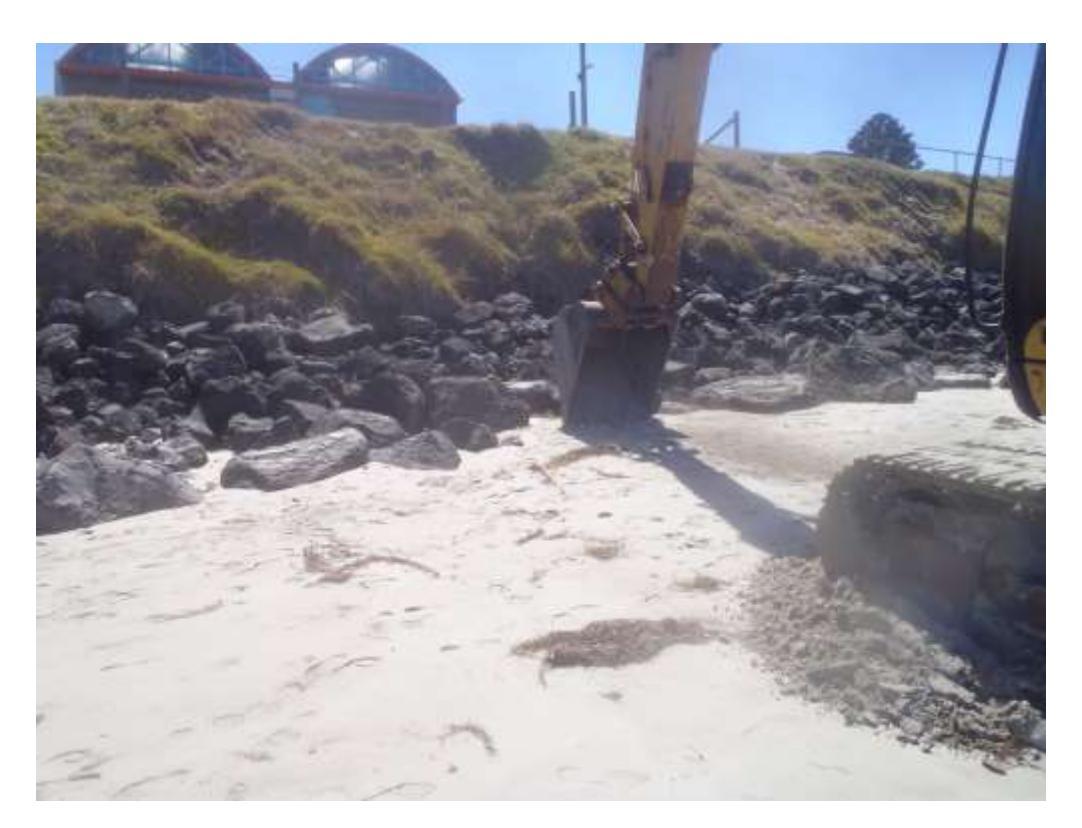
Figure 18 : Steep embankment above the seawall at the amenities building

The embankment slope is typically around the natural angle of repose for granular material, which is too steep for a seawall to be stable. Furthermore (except for near cross sections 24 and 25) the rock is small; and there is virtually no suitable primary armour rock within the structure. Figure 18 and Figure 19 illustrate the steepness of the wall and the location of infrastructure in close proximity to the crest of the embankment.

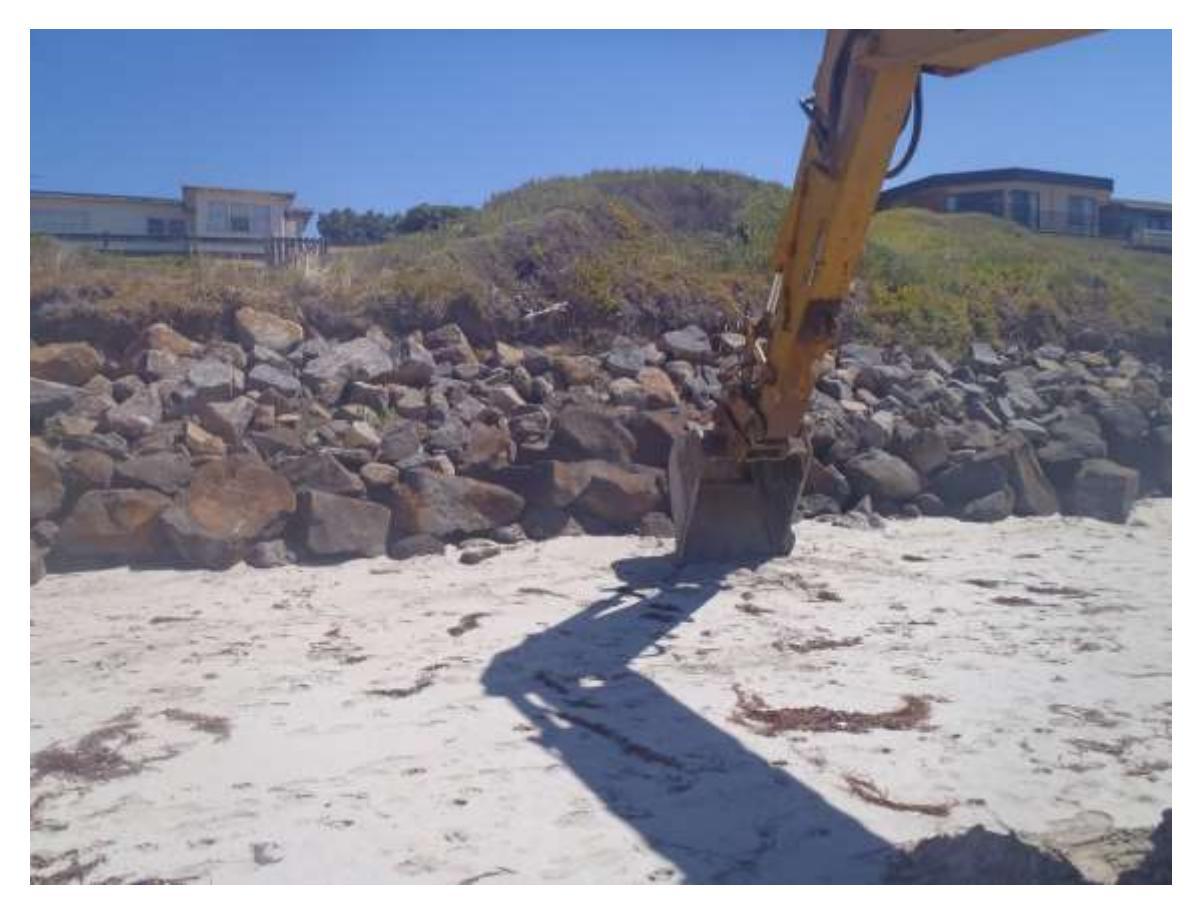
Figure 20 : Typical seawall – Sections 30 to 39

This section of wall would be damaged and erosion of the embankment behind it is likely to occur - but the extent of erosion is unlikely to impact on the dwellings behind the seawall. For the year 2100 climate scenario, there will be significant structural damage, and erosion may directly threaten adjacent properties.

The structural standard of this seawall type lies between that of the wall at Sections 16 and 17 and that of Sections 18 and 19. Consequently its priority for remedial works also falls between the priorities for those other seawall types.

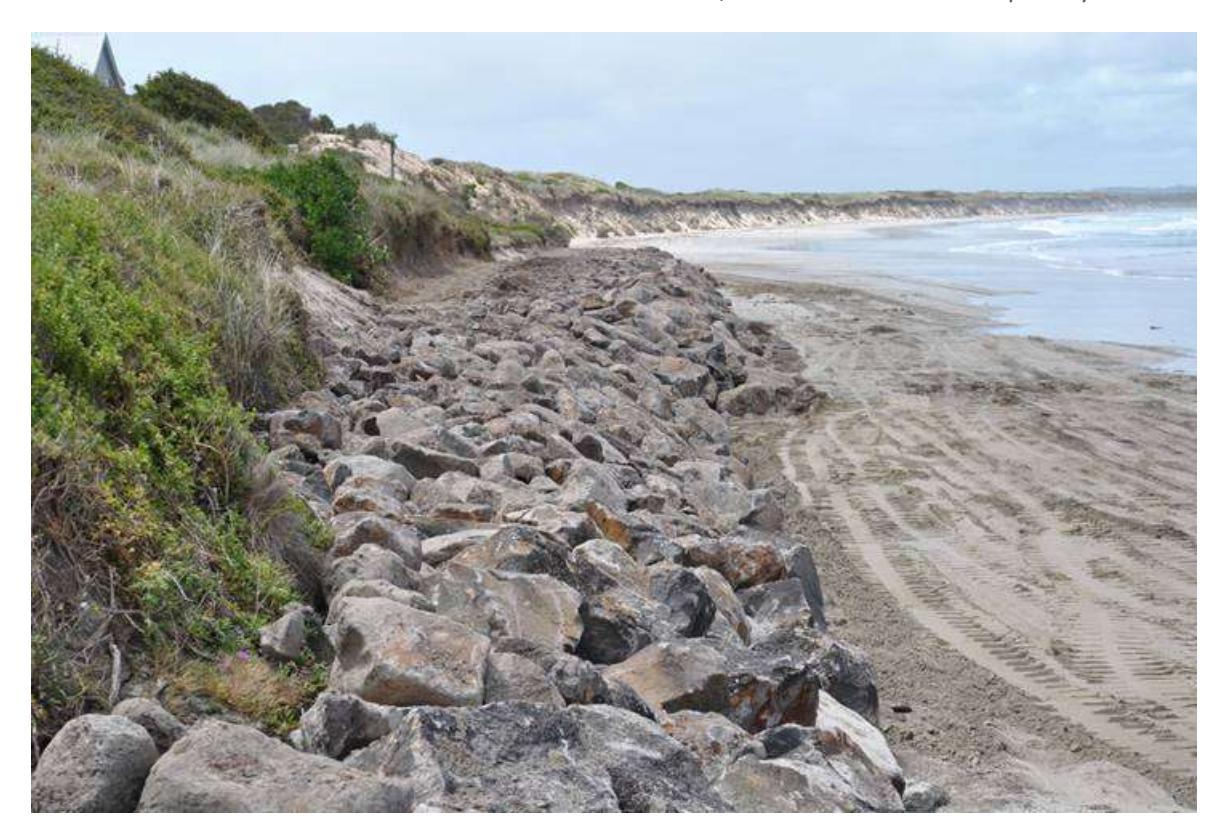
Figure 21 : Restored seawall between beach access steps and western end of 2012 seawall

Unlike the upgrading works completed in November 2012 on the seawall to the immediate north, no buttress rocks were installed at the toe of the seawall. Likewise the armour rock size was closer to 1 than to the 2 tonne specified for the upgrading.

Figure 21 shows the resulting rehabilitated seawall. It has a similar crest elevation as the works completed in November 2012, but the thickness of the armour is less. This particular section of the seawall will need to be dismantled and rebuilt to the structural standard of the 2012 seawall, but that work has a low priority.
