# **Biodiversity Assessment Report**

## **Mahoneys Ford Road – Brucknell Creek Bridge, Naringal**

**Report prepared by: Plume Ecology Pty Ltd, March 2025**

**Report prepared for: Moyne Shire Council**

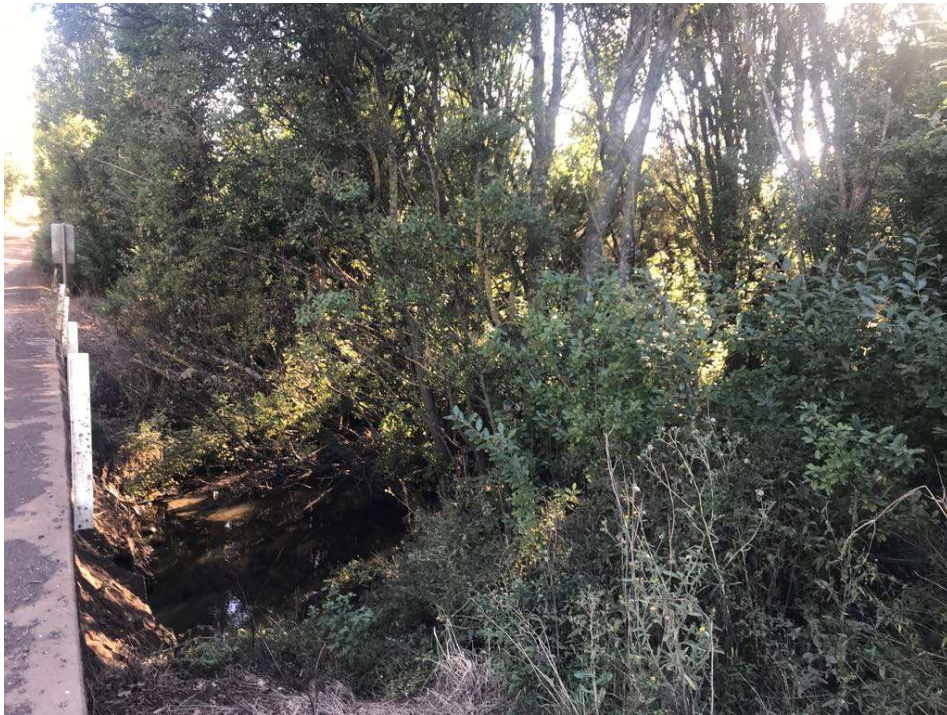
*Image 1: Vegetation on the eastern (upstream) side of bridge, choked with exotic woody weeds. Looking north.*

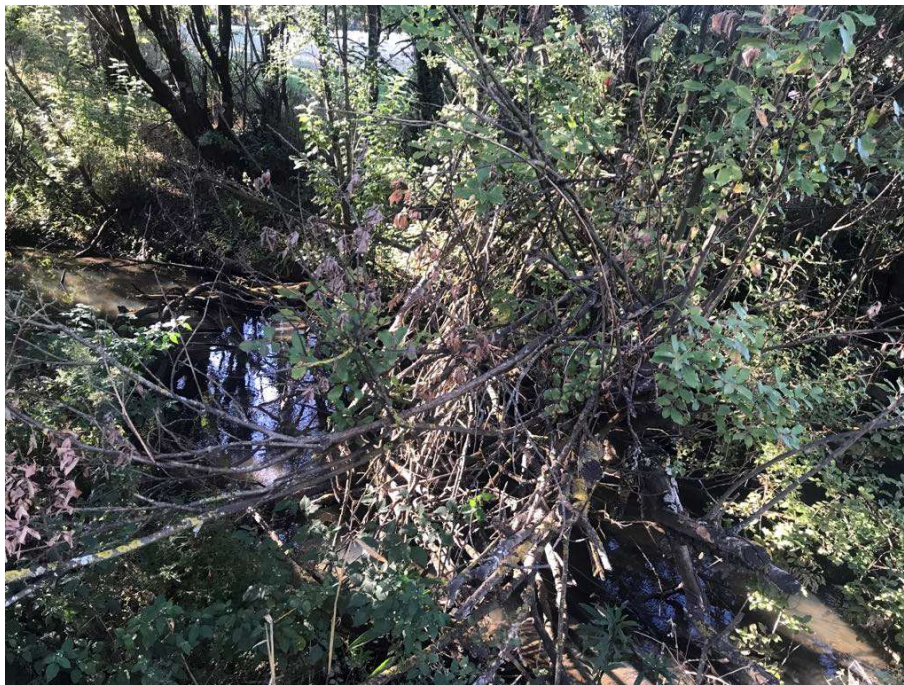
*Image 2: Instream vegetation on the eastern (upstream) side of bridge, choked with exotic woody weeds. Looking into waterway.*

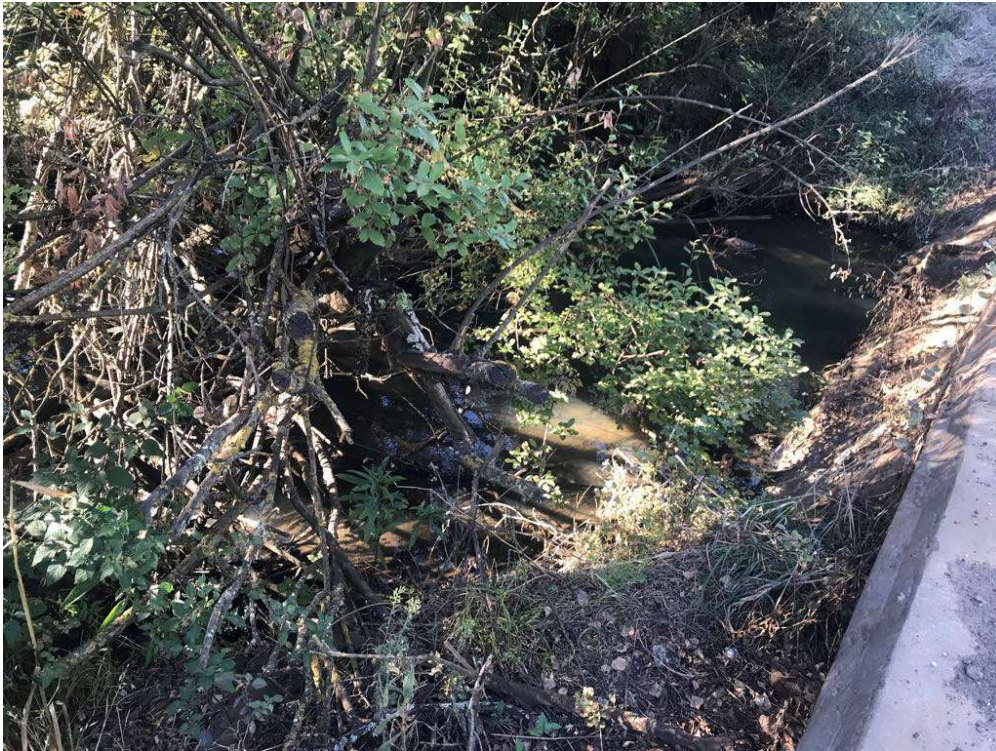
*Image 3: Instream and bank vegetation on the eastern (upstream) side of bridge, choked with exotic woody weeds. Looking south.*

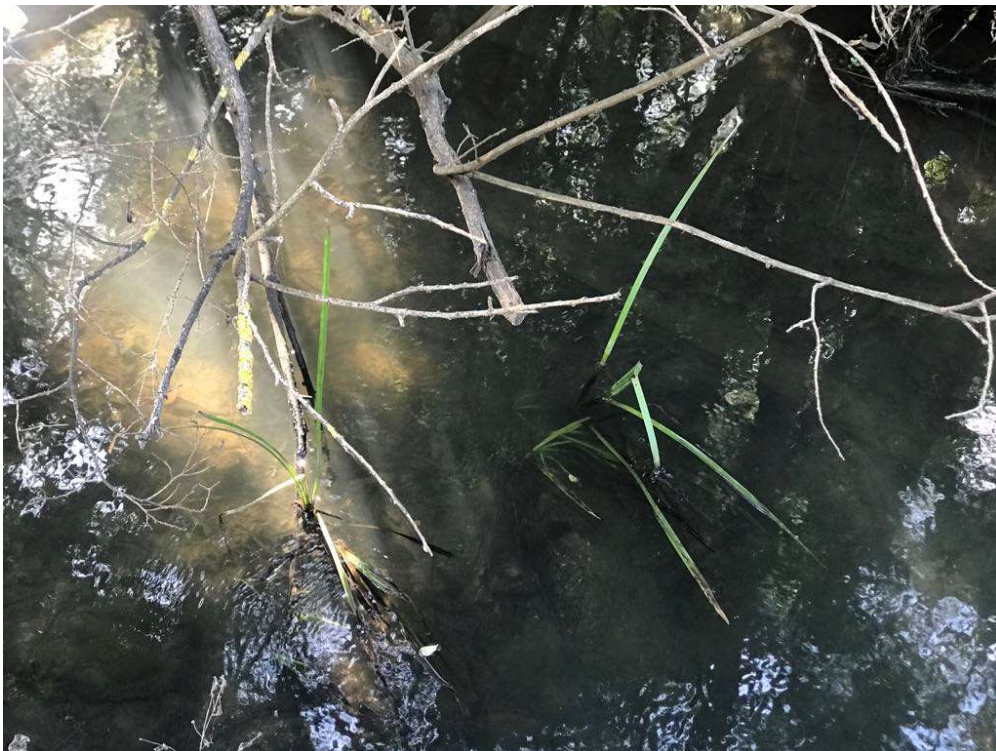
*Image 4: Scattered native sedge plants growing in the waterway vegetation (eastern/upstream side of bridge) that may be removed during debris removal works, requiring planning permit).*

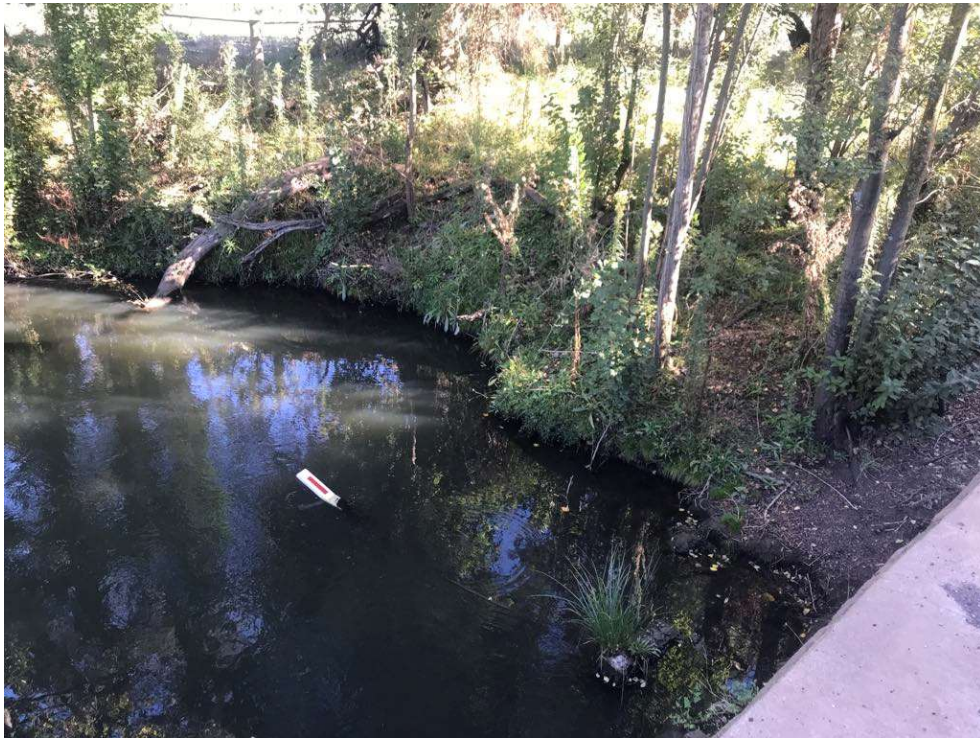
*Image 5: Vegetation on the western (downstream) side of bridge, more open water, exotic woody weeds especially on the banks. Isolated sedge plant growing in creek may be removed, or could be retained. Looking north-west.*

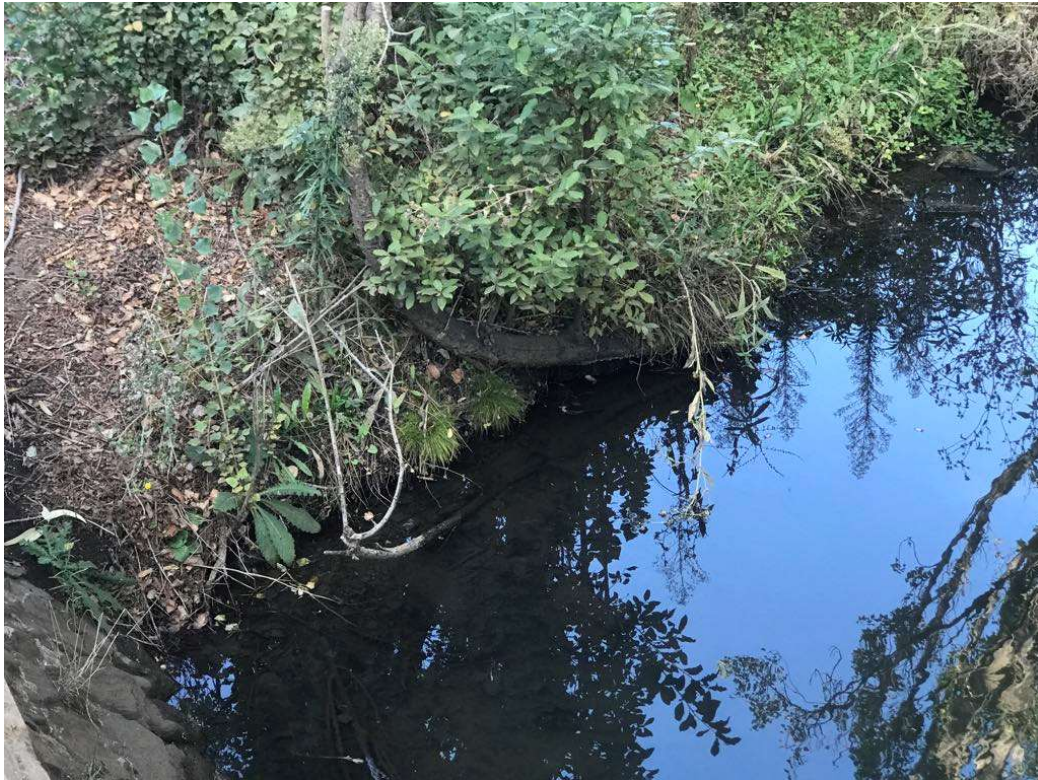
*Image 7: Streamside vegetation on the western (downstream) side of bridge. Many weeds, some native plants present (sedges growing on very edge of bank will not be impacted). Looking south-west.*

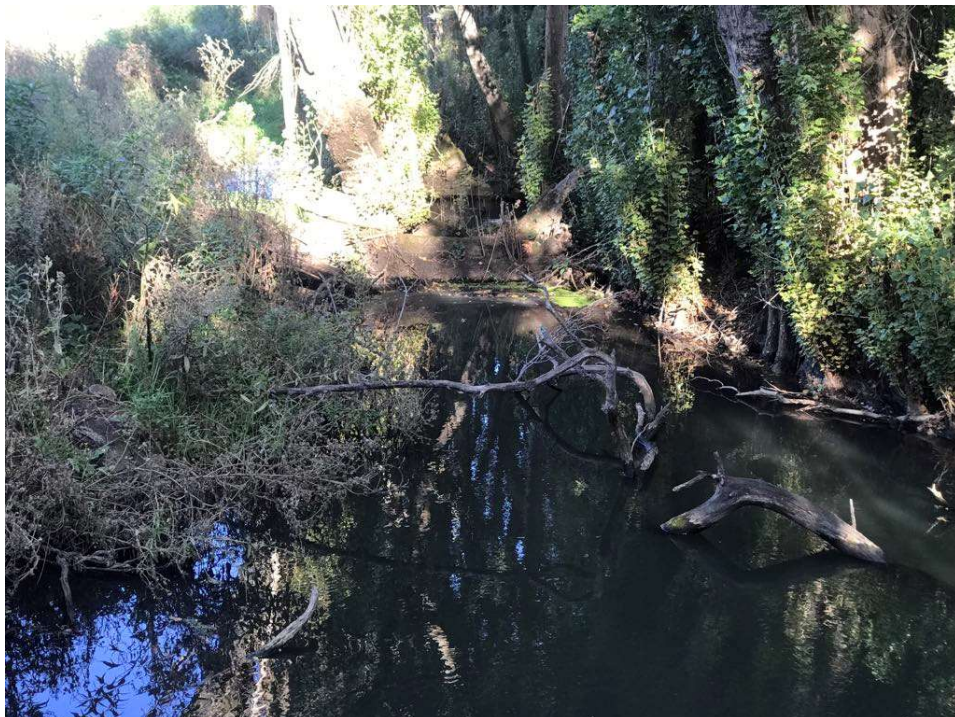
*Image 8: Instream habitat (exotic) on the western (downstream) side of bridge.*

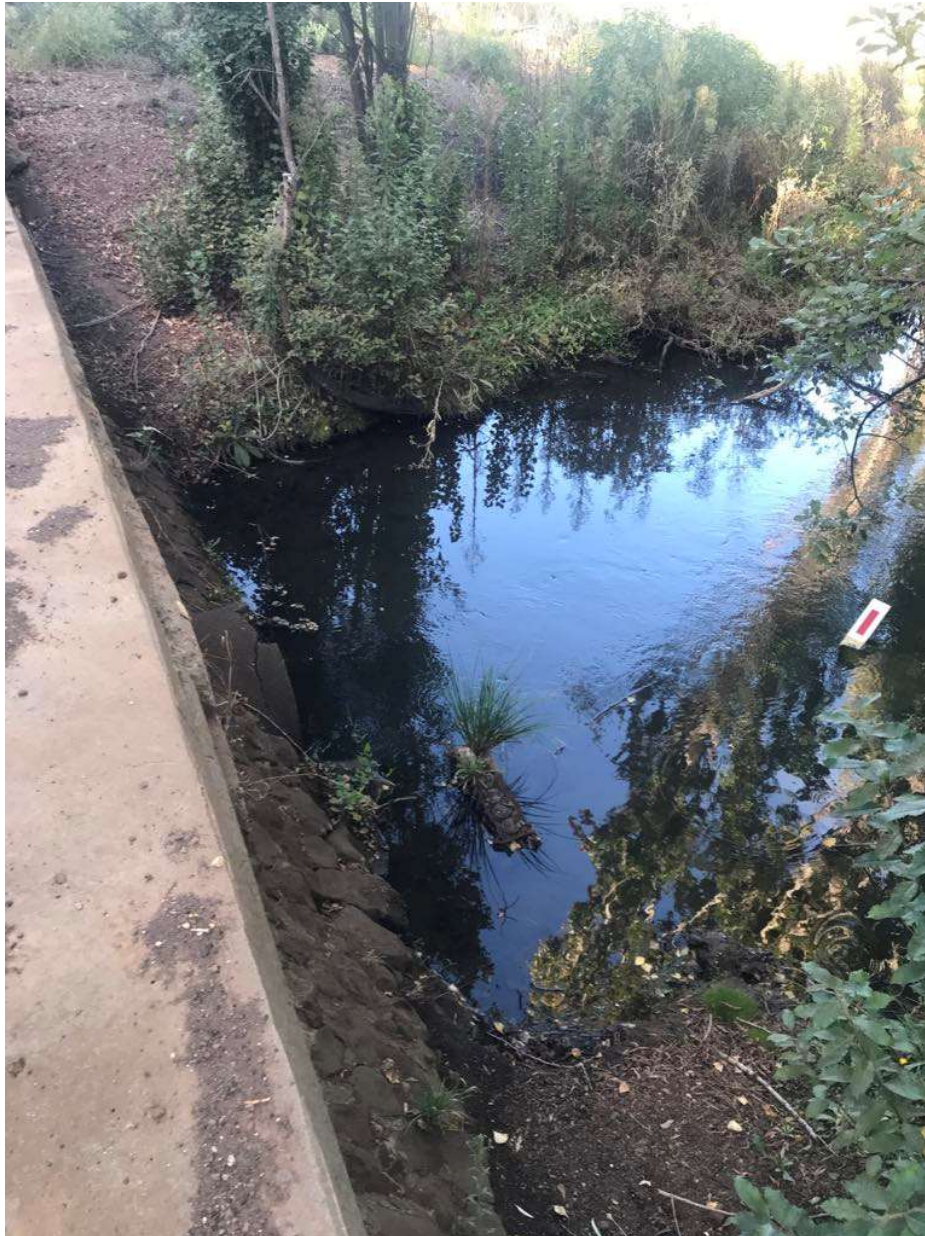
*Image 9: Another view of the western (upstream) side of bridge. Note exotic poplar suckers invading the banks. Looking south.*

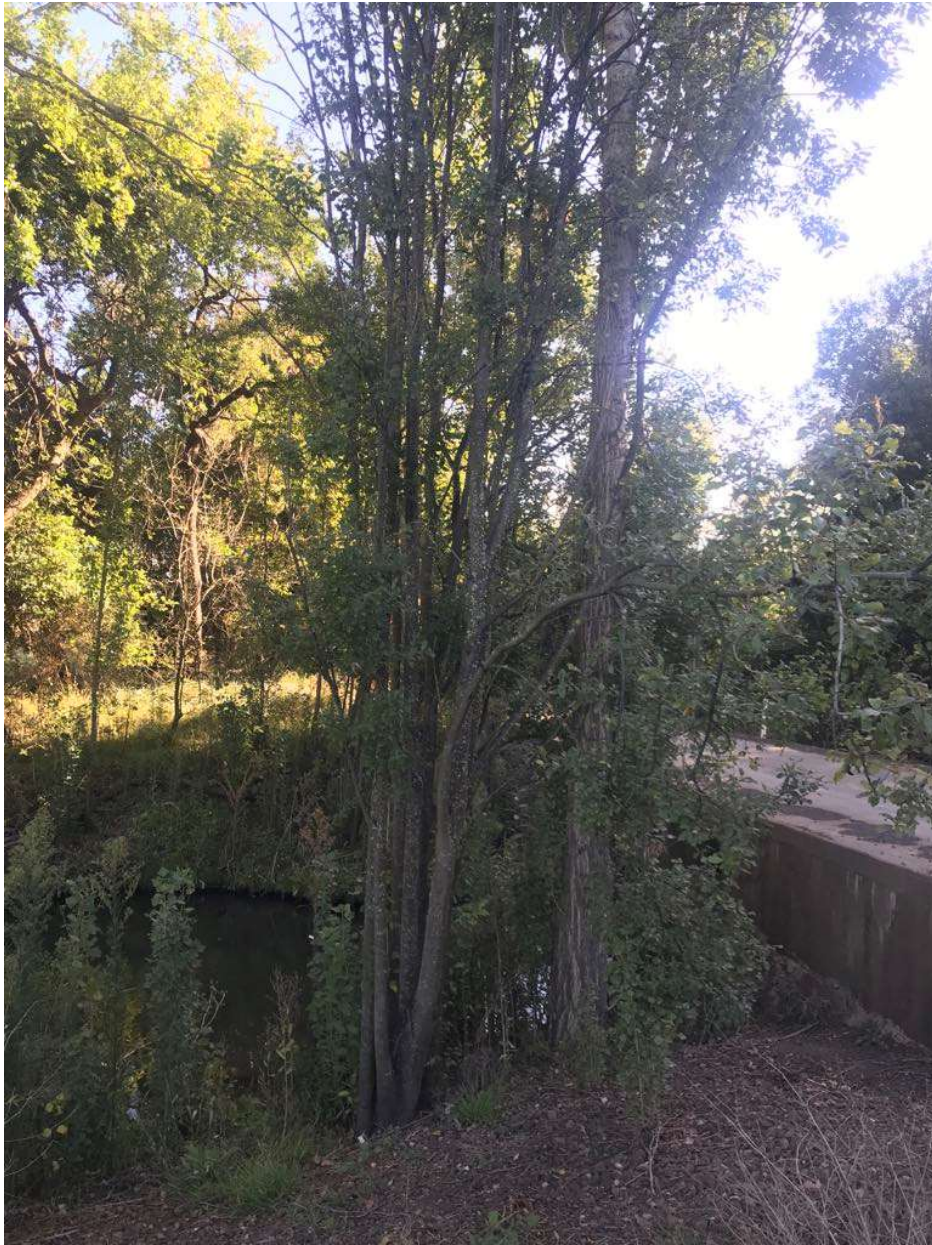
*Image 10: Image 9: Another view of the western (upstream) side of bridge. Note exotic poplar suckers invading the banks. This section of the site (top bank) is very weedy. Looking north.*

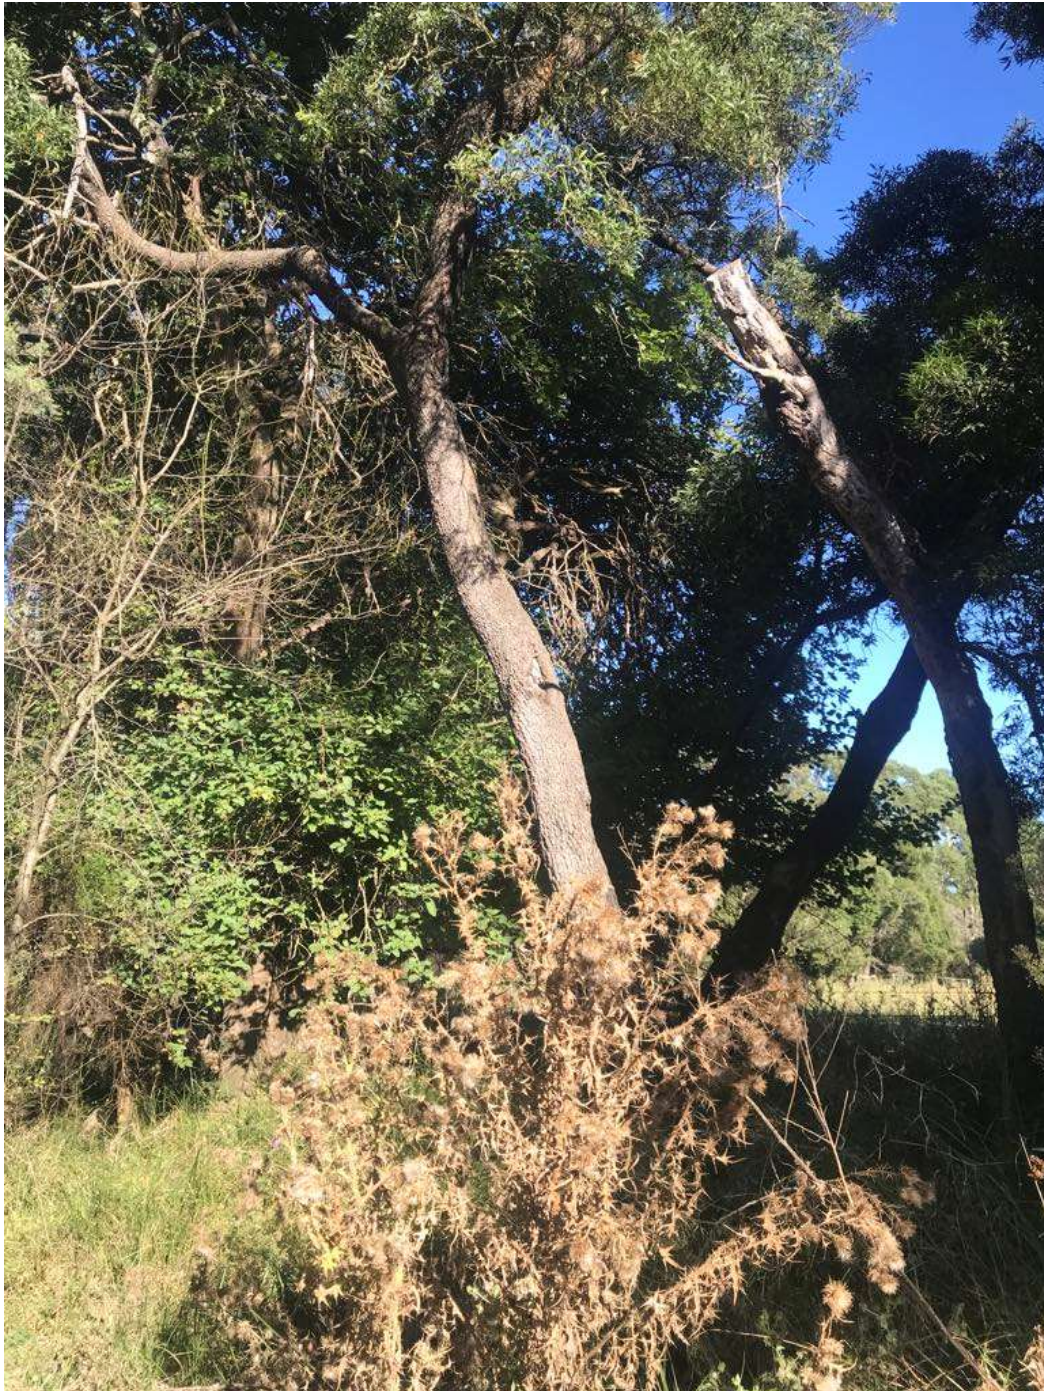
*Image 11: Blackwood (Acacia melanoxylon) growing on the northern bank, western (upstream) side of bridge – to be protected during works.*

4.4 Any areas of native vegetation to be protected during works should be highlighted using temporary hi-visibility fencing or tape/bunting and marked as no-go zones (native riparian vegetation adjacent to the work zone should be demarcated and protected during works – especially the Blackwood trees).
