# Port Fairy Coastal Climate Change Adaptation Plan

## Discussion Paper

Moyne Shire - a safe, vibrant, liveable, and prosperous community

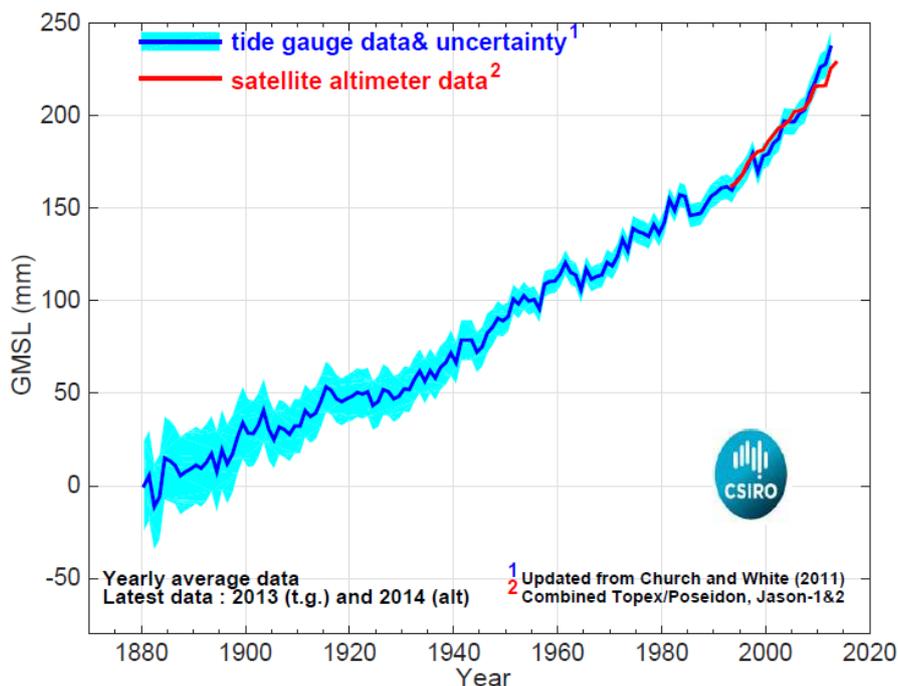
Figure 1 Global average sea level rise

Global average sea level will continue to rise during the 21st century (Figure 1) (CSIRO, 2016). The rate of sea level rise will very likely exceed that observed during 1971 to 2010 due to increased ocean warming and increased loss of mass from glaciers and ice sheets. (Intergovernmental Panel on Climate Change, 2013)

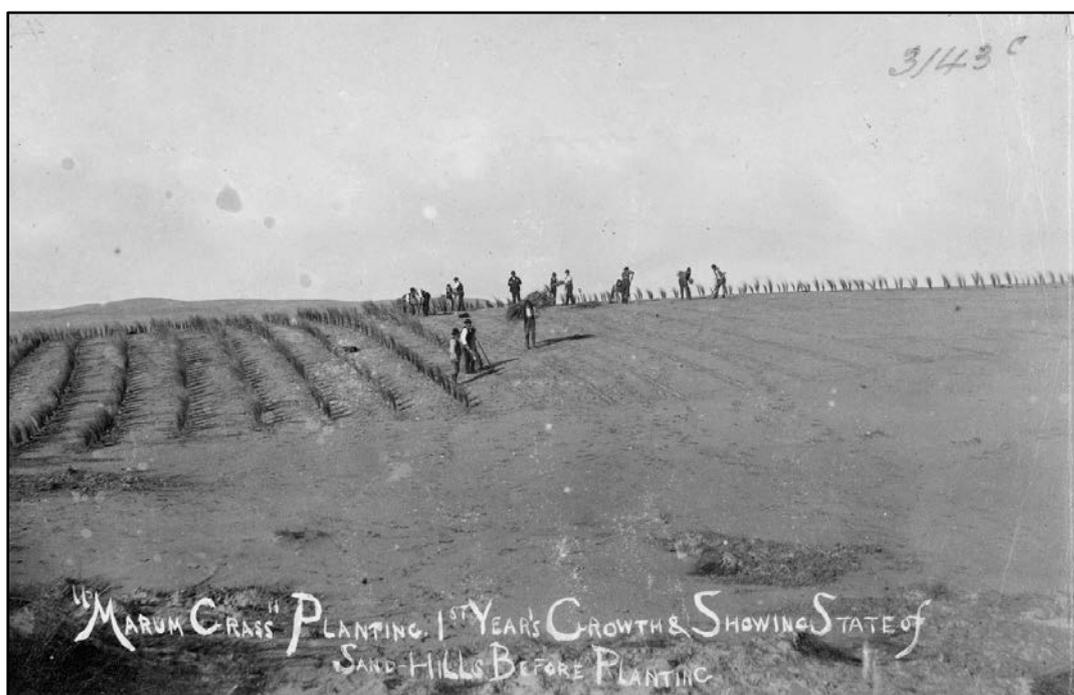
Figure 2 Planting of marram grass to prevent further loss of sand

Wind erosion of the dune systems is occurring today, however significant losses from wind occurred in the early 1900's when cattle grazing led to loss of protective vegetation cover and extensive dune instability. Figure 2 shows marram grass being planted to prevent further sand loss due to wind (WBM Pty Ltd, 2007).

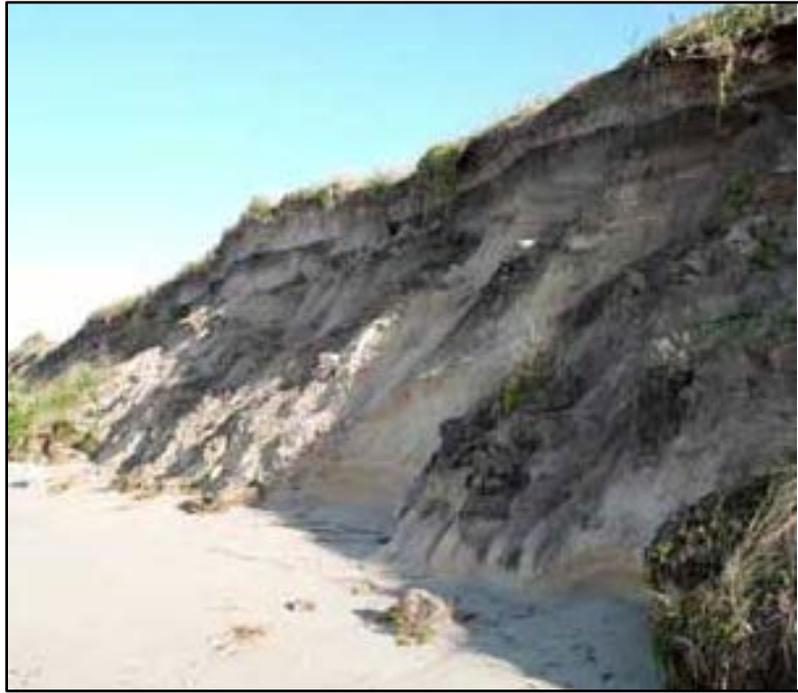
*Figure 3 Erosion of an East Beach sand dune*

Figure 3 shows recent coastal erosion on the East Beach sand dunes.

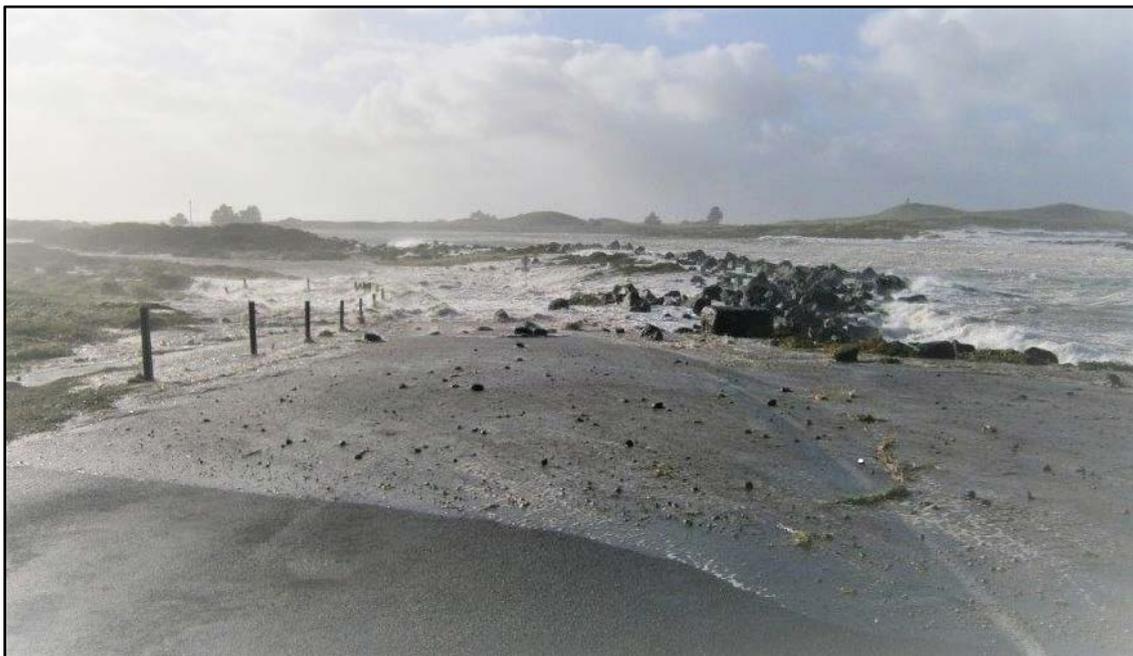
*Figure 4 Inundation Ocean Drive, South Beach Port Fairy, June 2014*

**Coastal Inundation** is predominantly the result of wave run-up, created by tide, storm surge and riverine catchment influence (Water Research Laboratory, 2013). Figure 4 depicts recent coastal inundation on South Beach.

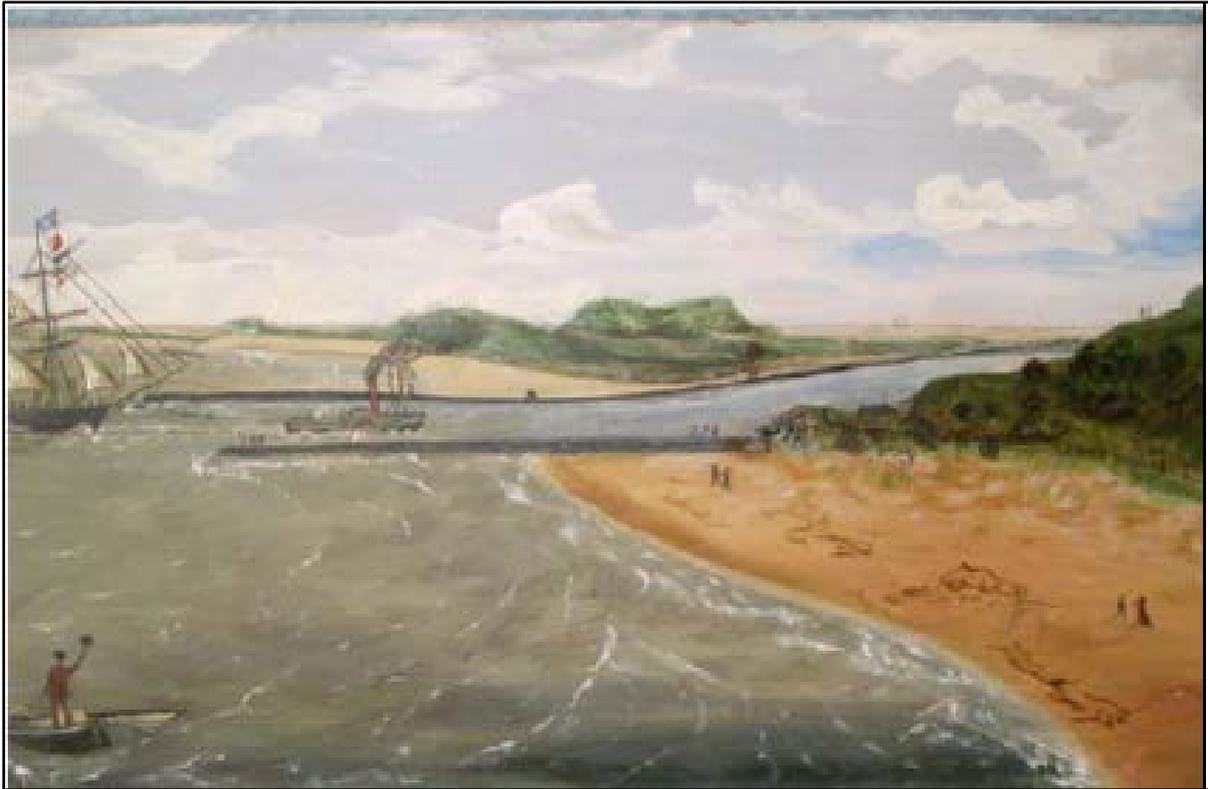
*Figure 5 East Beach: Painting of training walls, 1904*

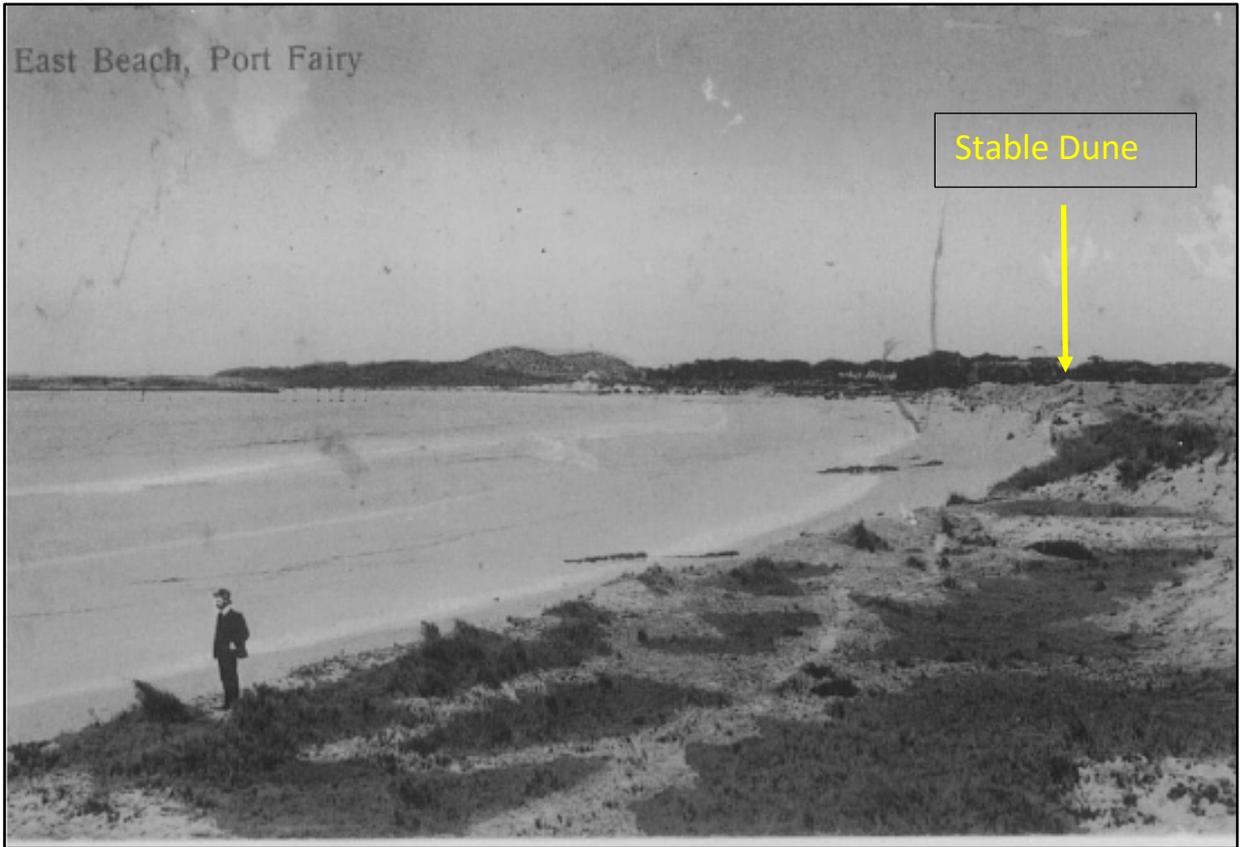
Figure 6a East Beach 1915, around time of closure of Southwest Passage

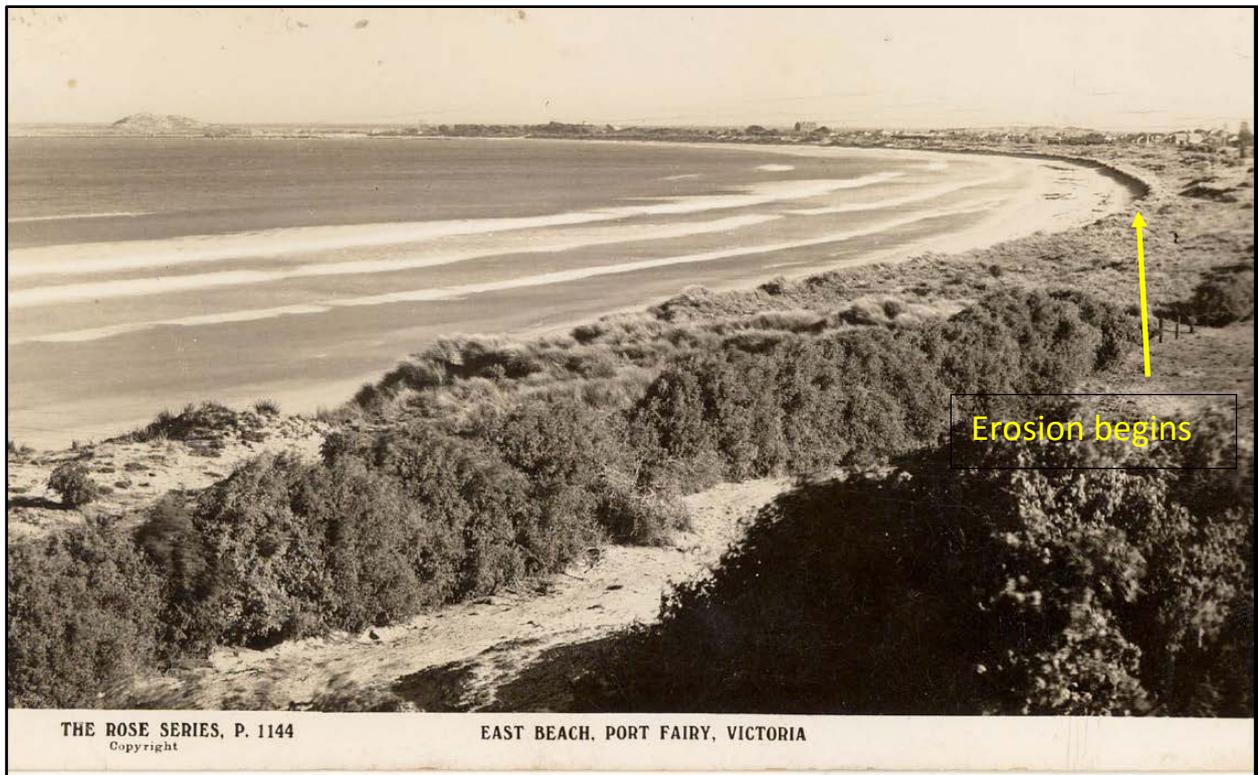
Figure 6b East Beach 1920, five years following closure of Southwest Passage, erosion begins

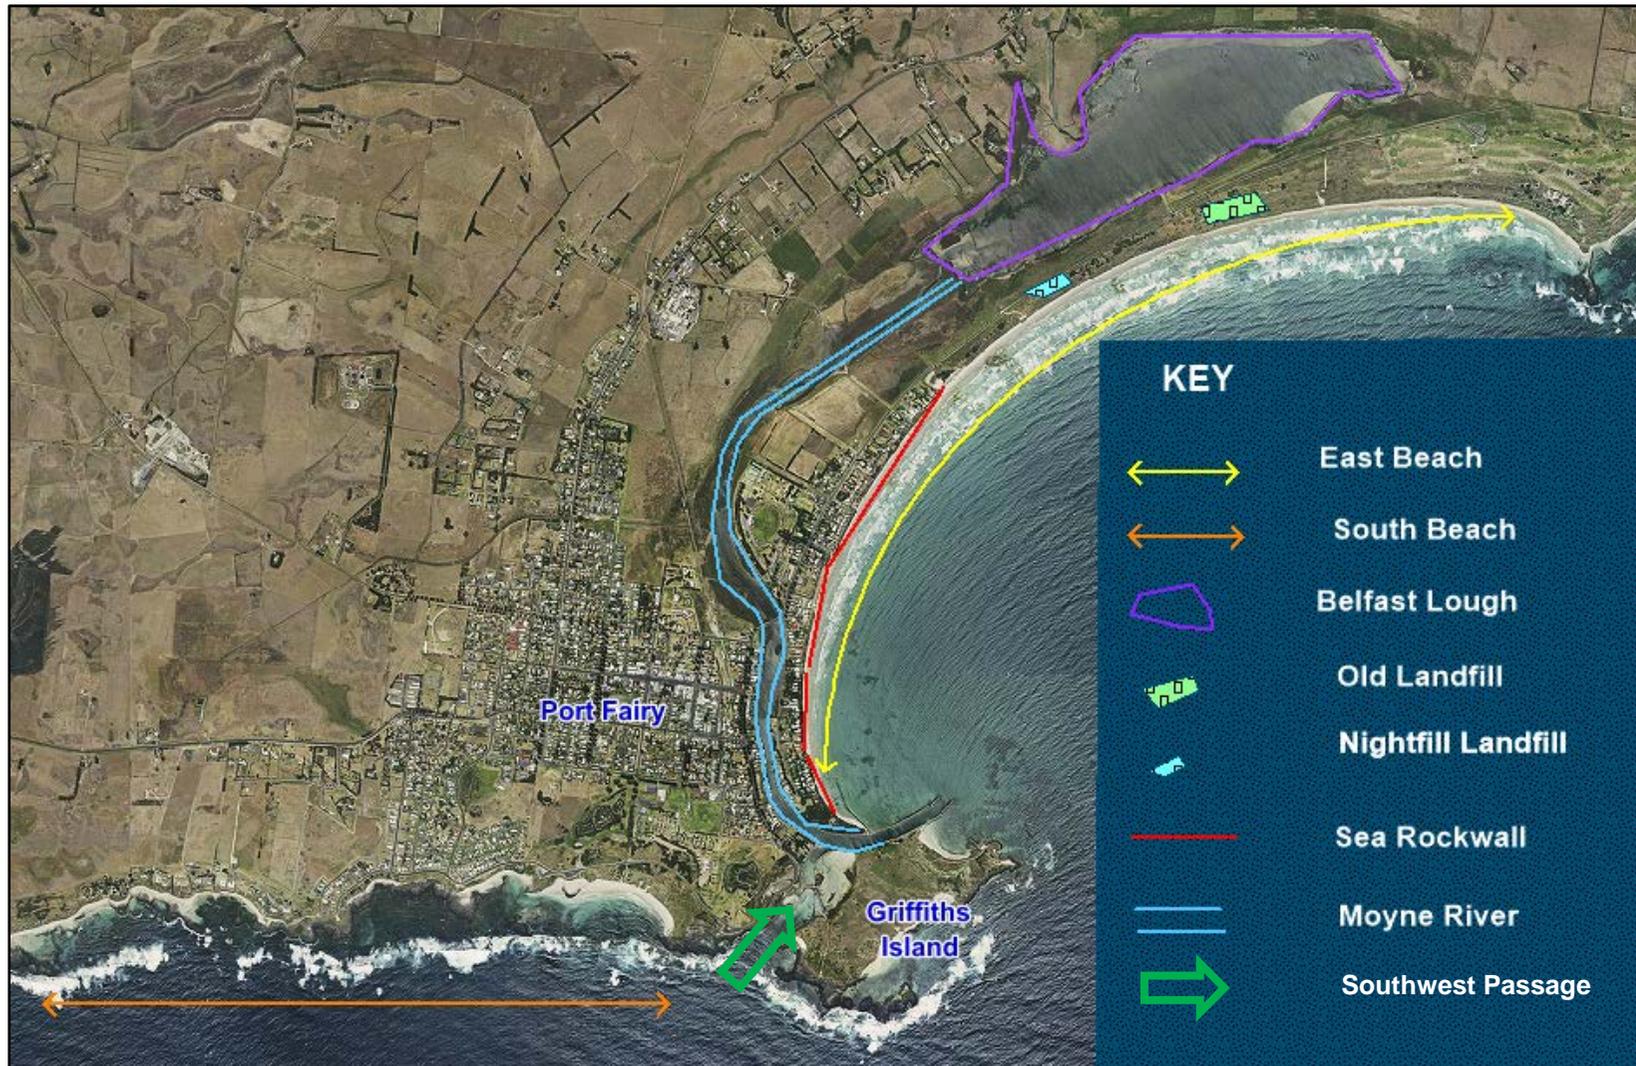
Figure 7 Key Coastal Features Port Fairy

Figure 7 depicts the approximate location of key features as described throughout the discussion paper.

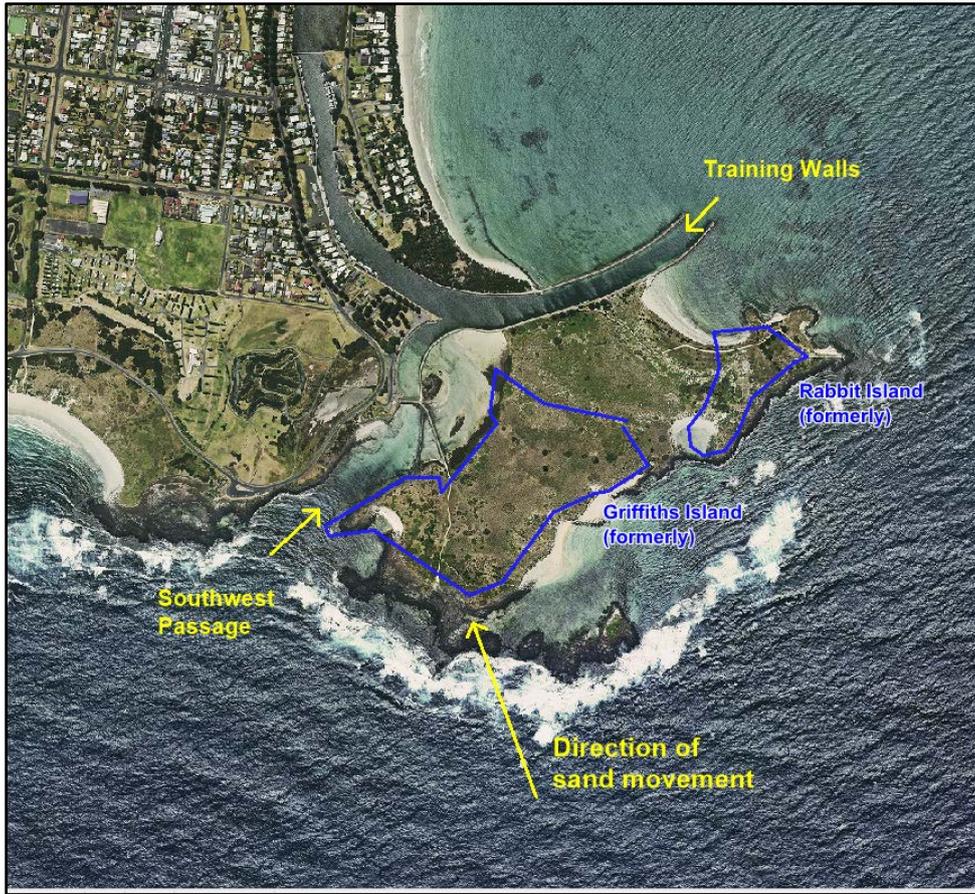
Figure 8 View of Griffiths Island showing key features and former separate islands

East Beach has experienced considerable change over the past 100 years in response to the Moyne River training walls and blockage of the Southwest Passage (Figure 8). The rationale for the construction of these features was to maintain the navigable entrance channel to the Port.

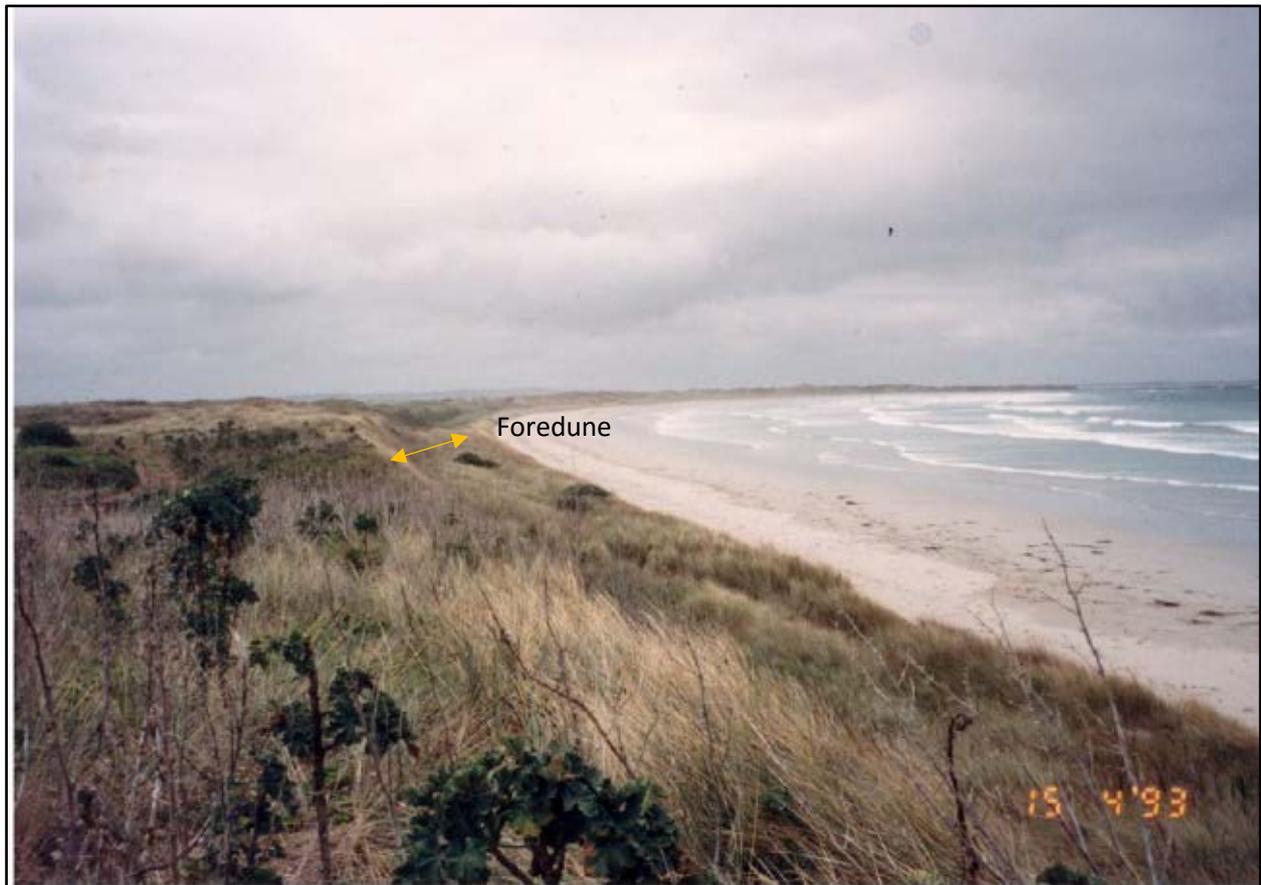
*Figure 9 East Beach Foredune 1993*

A substantial fore-dune existed in 1993, along most of East Beach, as depicted in Figure 9.

A 2006 report on East Beach shoreline stability showed a very similar image of the foredune. However, since 2007 there has been progressive erosion of the foredune without the dune re-establishing itself. (Coastal Engineering Solutions, 2006)

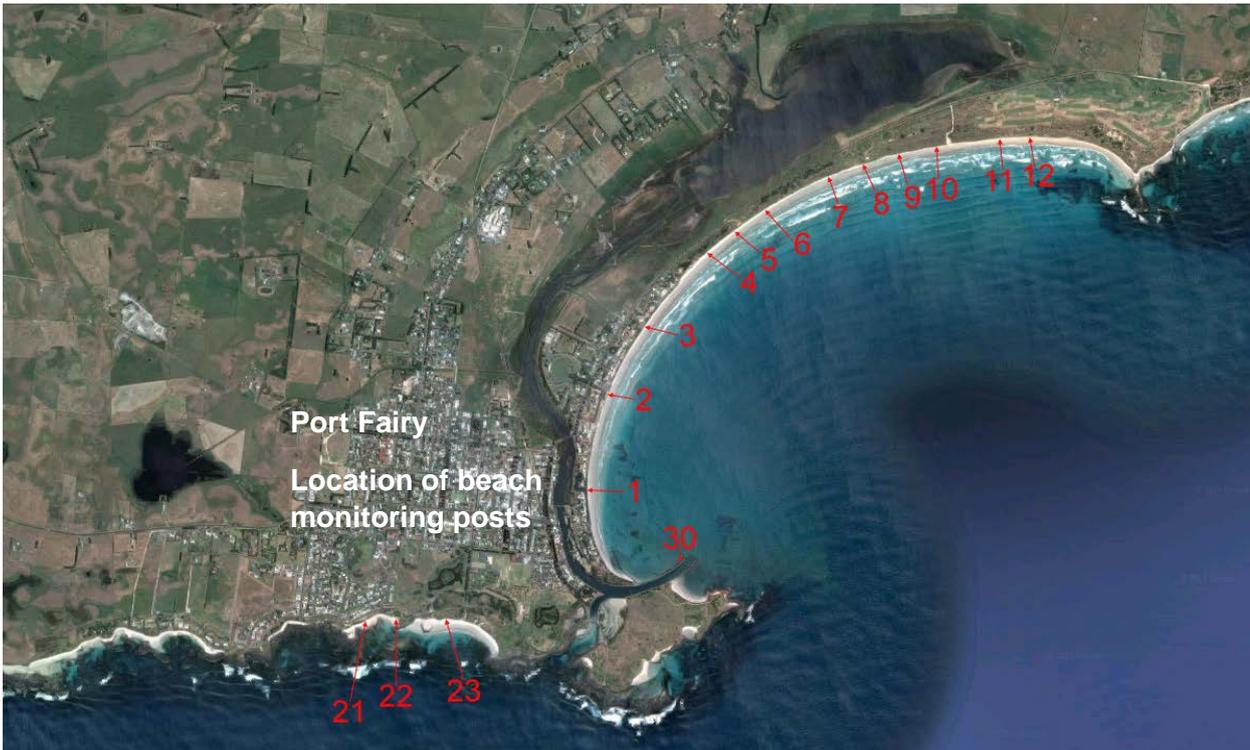
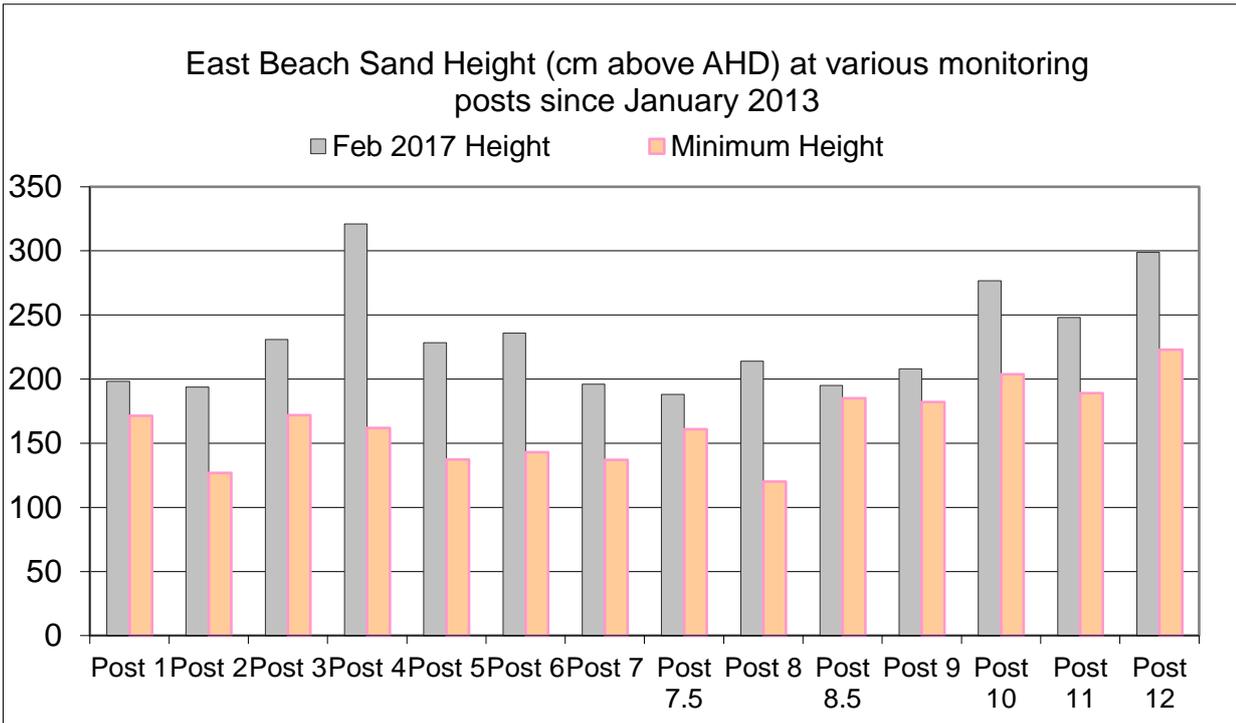
Figure 10 East Beach sand height and location plan of monitoring posts (Port Fairy Coastal Group, 2017)

Information acquired from the PFCG monitoring of East Beach as depicted in Figure 10 includes:

- Several areas along East Beach show differing seasonal responses with sand return taking several months. Annual sand loss tends to occur almost simultaneously over the whole of the beach.
- Areas of East Beach between the rock seawall and the 'Nightsoil Landfill' (Post 4) have excellent sand build up.
- The area in front of the 'Old Landfill' (Posts 7.5 – 8.5) that is now protected by the Wave Energy Dissipation Structure (WEDS) continues to demonstrate the capacity for active sea erosion. As indicated at Post 8 in Figure 11, the WEDS appears to be preventing high-energy waves from reaching the dune toe.
- Evidence of sand height movement is first detected at a point 30m seaward from the reference Post. Data from this area is most likely to yield information on the influence of various weather and tidal factors.

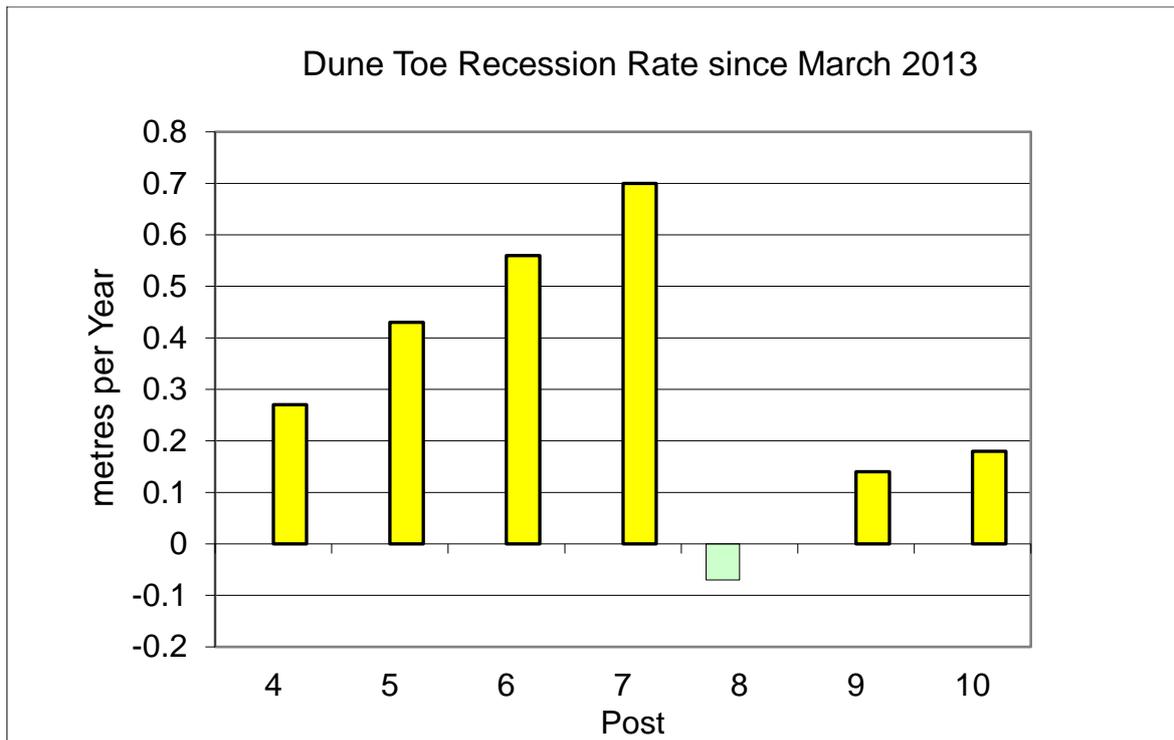
Figure 11 East Beach dune toe recession rate (Port Fairy Coastal Group, 2017)

Overall, the north-eastern section of East Beach is stable in terms of net sand height (volume), but since 2013, the dunes are receding at a rate of at least one meter per year where no rock seawall is present.

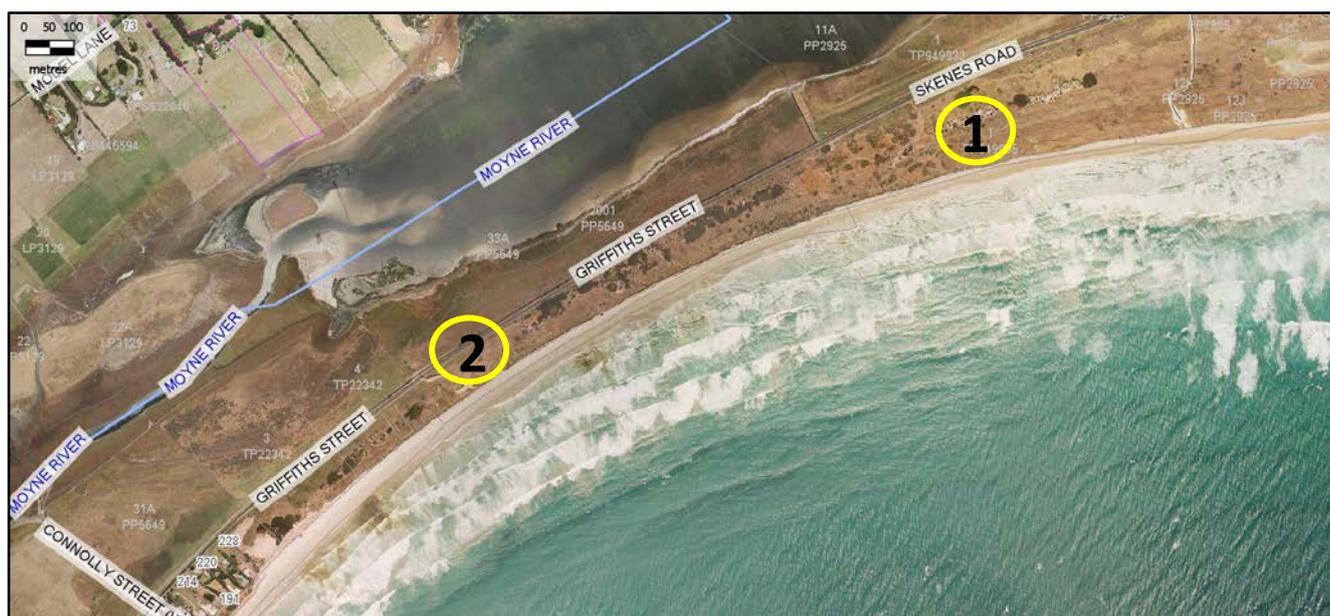
Figure 12 Approximate location of landfills, Port Fairy East Beach sand dunes

Two closed landfills exist within the north-eastern section of the East Beach sand dunes (Figure 12).

Landfill 1, Moyne Shire Council own and manage the 'Old Landfill', located opposite the Port Fairy airstrip on Skenes Road. Whilst the surface area of the landfill is 115,000m<sup>2</sup> it is estimated that waste covers a maximum of 30,000m<sup>2</sup>. Operating between 1970's and 1990's, the compacted waste cells contain putrescible waste and recyclable materials including plastics, glass and aluminium bottles, building materials and scrap metals

Landfill 2, The State Government, Department of Environment, Land, Water and Planning own and manage the 'Nightsoil Landfill', located approximately 700m northeast of Connolly Street. The site is significantly smaller than the Old Landfill and the waste predominantly consists of scrap metal, nightsoil pans and glass bottles.

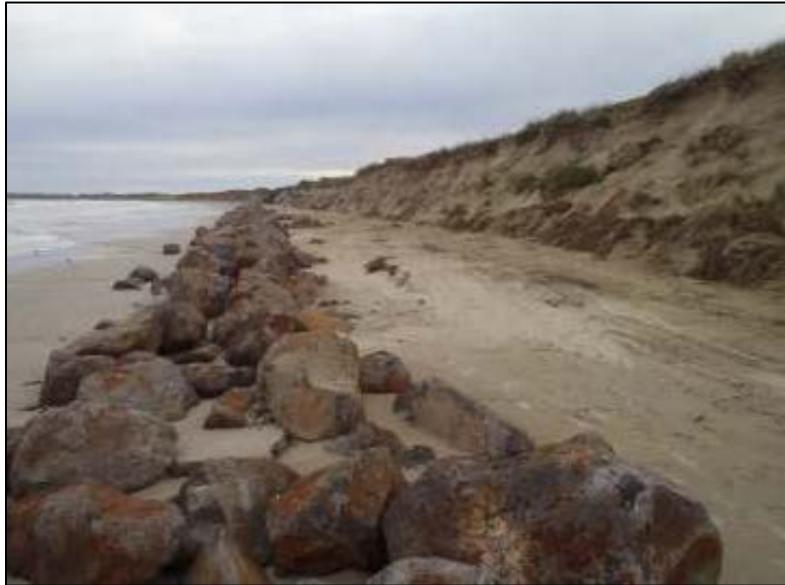
*Figure 13 Wave Energy Dissipation Structure (WEDS) at the Old Landfill East Beach*

A Wave Energy Dissipation Structure (WEDS) was constructed seaward of the Old Landfill in 2014 and extended in 2015 to a total length of 280 metres (Figure 13). The WEDS is considered to be a temporary structure with a limited lifespan.

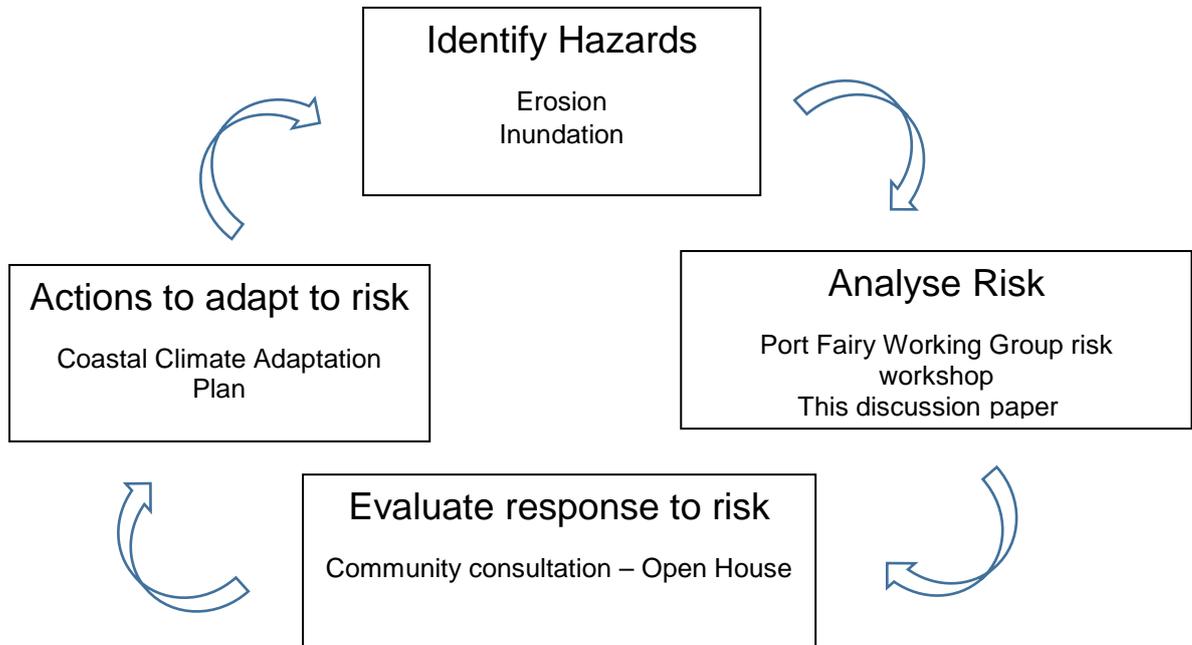
Figure 14 Summary of risk assessment steps

In order to prepare for the future and build a resilient community, a risk based approach was used to assist with the identification of potential hazards and the prioritisation of projects/works to minimise the risks. The process as depicted in Figure 14 underpins the process used to define and minimise the risks.

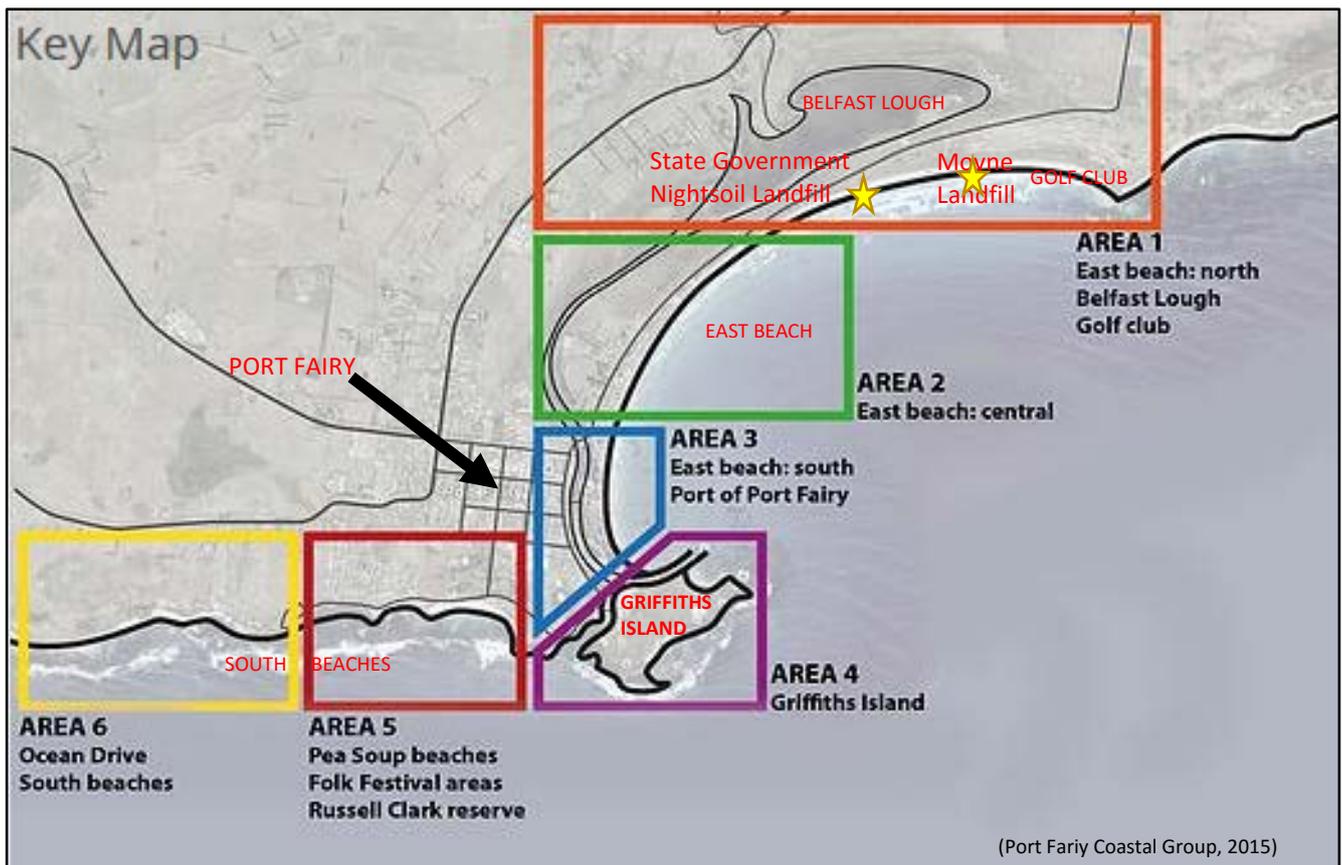
Figure 15 Areas of Moyne Shire at risk from coastal hazards

A risk assessment undertaken by the Port Fairy Working Group in 2015 identified six distinct areas within Port Fairy that are at risk from coastal hazards, Figure 15. The preliminary risk assessment included community feedback on specific, high-risk areas.
