Port Fairy East Beach Coastal Erosion Engineering and Feasibility Study

Coastal Erosion

Engineering & Feasibility Study

Prepared For: Moyne Shire Council

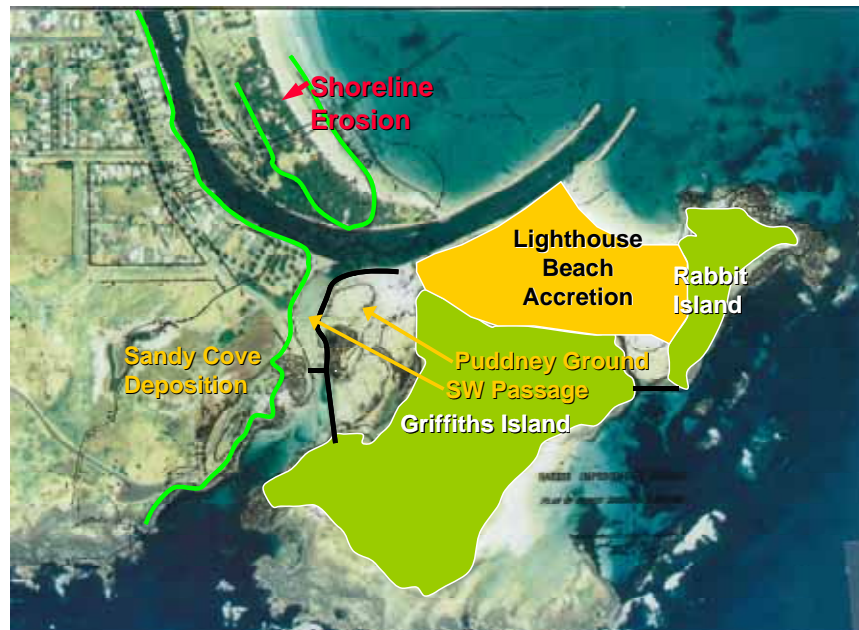
Figure 2-1 Original Shoreline and Sand Deposition Areas at Griffiths Island

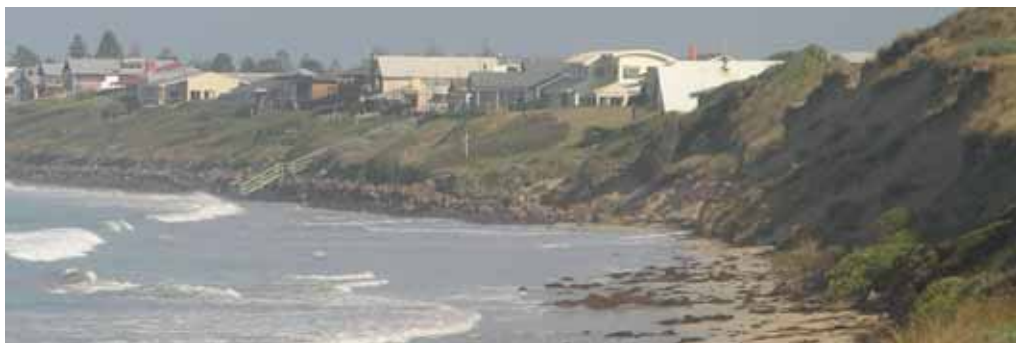
Figure 2-6 Rock Seawall Extended Past Connolly Street (2006)

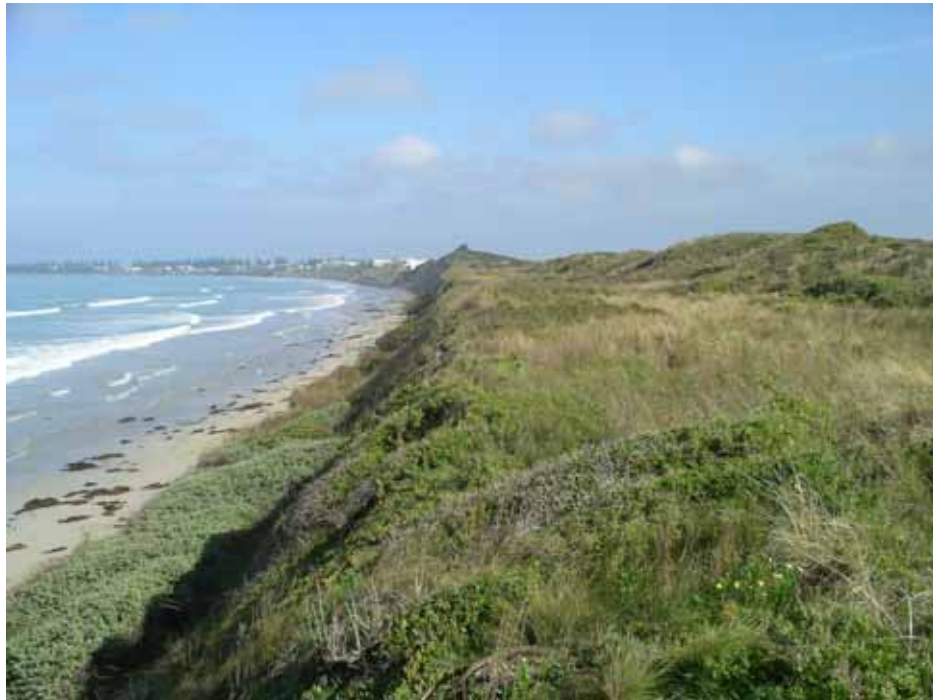
In the presently undeveloped area immediately to the north of East Beach, the key objective is to prevent an erosion problem from occurring in the future. That is, allowing the natural beach

Photo 2: Undeveloped Area North of existing East Beach development

The most appropriate coastal management strategy there is to prevent construction of development and facilities in the erosion prone area. The natural processes, including shoreline fluctuations, will thus be allowed to continue unimpeded and the natural amenity and character of the beach will be retained.

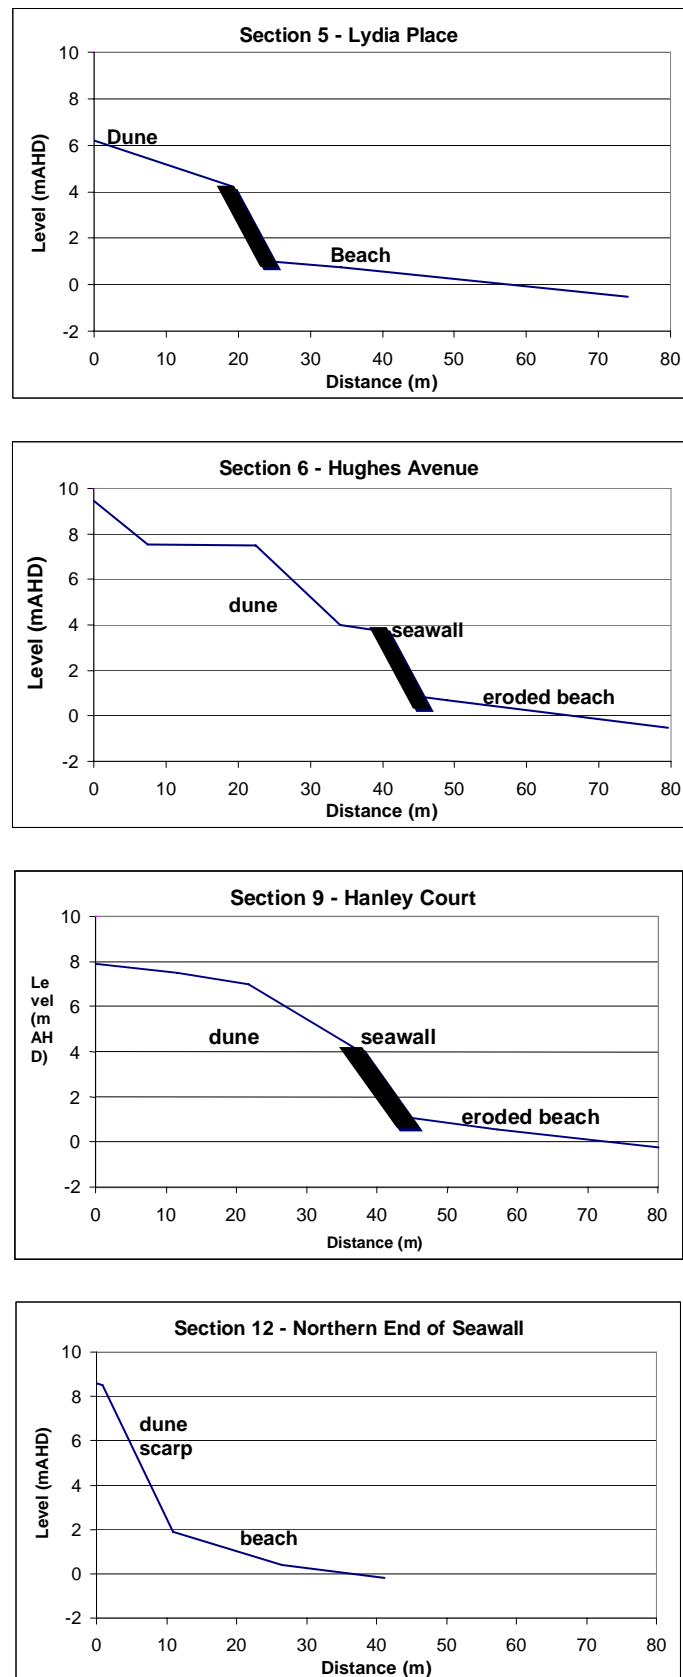
Figure 3-1 Typical Survey Cross-Sections along East Beach

The residential and road development along East Beach has been under direct threat from erosion. A seawall was constructed during the 1960s and subsequently to protect the development. Typical beach and dune cross-sections along East Beach are shown in Figure 3-1.

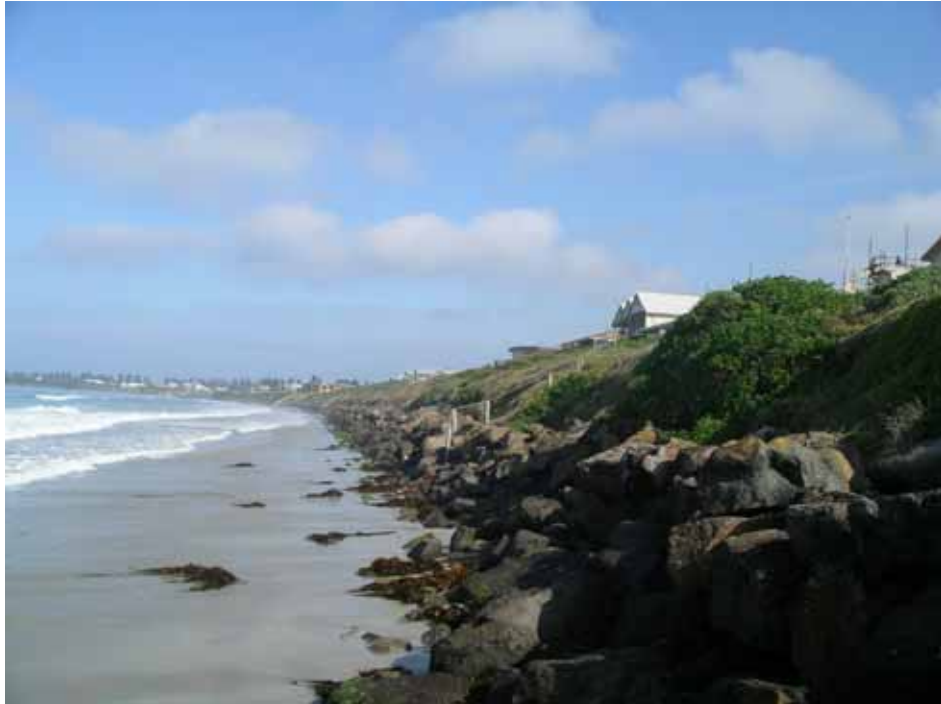
Photo 3: Seawall constructed in 1960s to protect development located on dune

The seawall has been constructed progressively over time, without an attempt to comply with conventional engineering design principles in terms of backing filter layers or toe protection. This appears to allow slumping and leaching of sand from behind in some areas. As such, the long term integrity of the seawall as a protective barrier would be in question in the absence of either ongoing maintenance and repair or upgraded construction.

Despite this, the seawall has been effective in holding its alignment along what would otherwise have been an eroding section of beach and dune. Rock placed initially has settled into the sand and established a reasonably sound foundation in most places. Only those sections of seawall towards the northern end appear to be susceptible to failure in the short term.

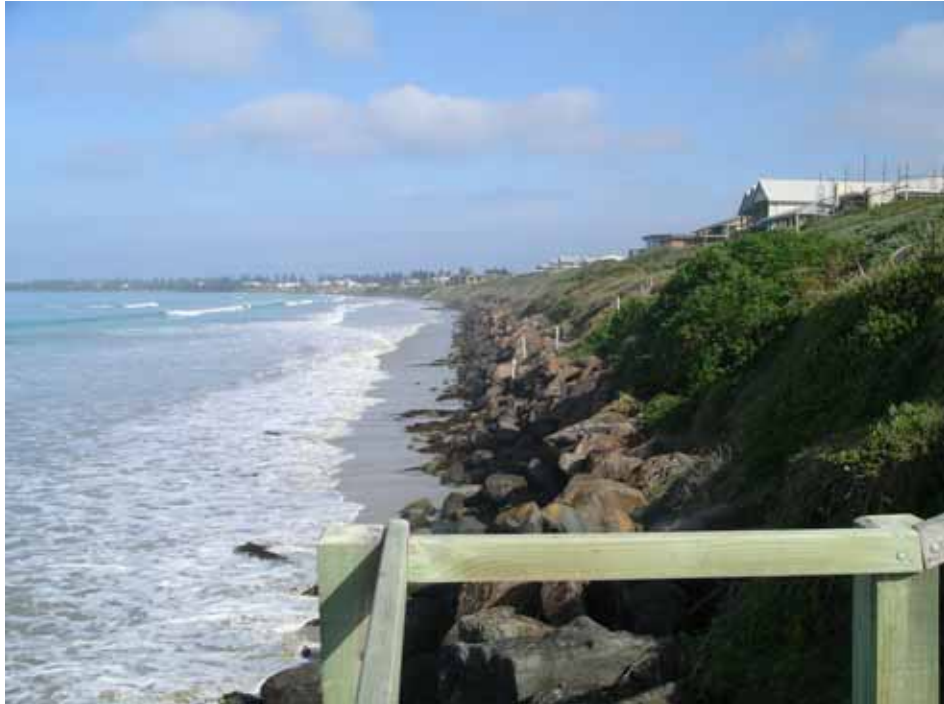
Photo 5: Seawall at East Beach has caused loss of usable beach

Scour and lowering of the beach in front of the wall ultimately exposes it to higher wave attack and can lead to slumping and the need for ongoing maintenance. Such maintenance is typically in the form of topping up of the wall with additional rock. However, where the seawall is not adequately designed or constructed, complete reconstruction may be needed.

Seawalls in isolation can thus be effective in protecting the property behind, but at a cost of the loss of the beach in front and exacerbated erosion on the downdrift side.

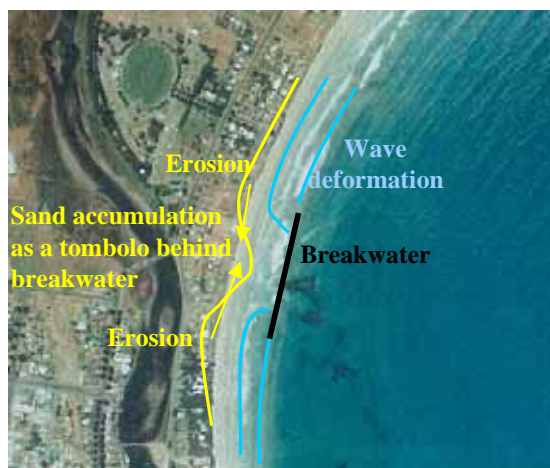
Figure 3-3 Typical Breakwater Behaviour

Offshore breakwaters and submerged reefs are robust structures constructed offshore from the beach and function by altering the height and direction of waves reaching the beach and/or the pattern of currents affecting sand transport such that the beach is built up in particular areas. They are typically constructed parallel to the shoreline, diffracting the approaching waves and creating a sheltered zone in which sand moving along the coast under longshore transport processes is trapped and accretes, forming a salient or tombolo (Figure 3.3). As for groynes, this trapping effect starves the downdrift beaches of sand, leading to erosion there.

Other breakwater forms may be oblique to the shoreline and may or may not be attached at their shoreward end. Nevertheless, their fundamental function is to cause a change in the wave/current field and an associated change in sand transport patterns, to the benefit of particular parts of the beach.

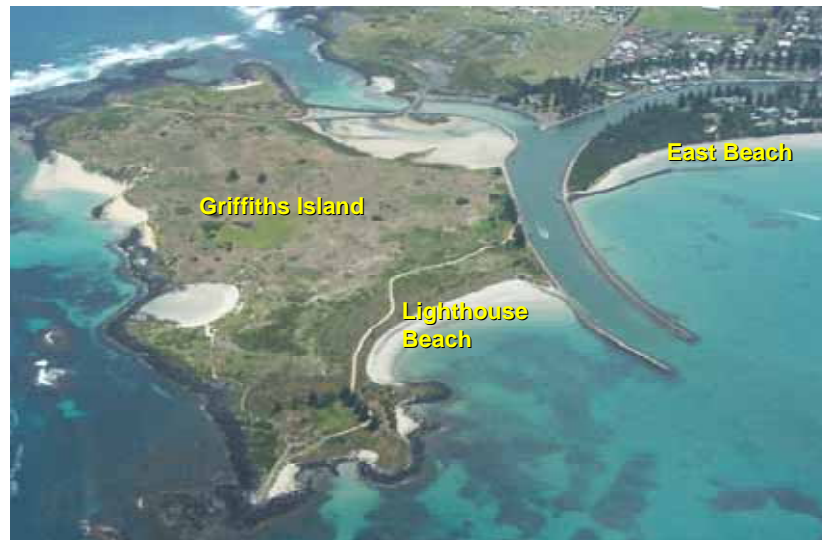
Figure 3-5 Lighthouse Beach

Sand deposits in the Griffiths Island and South-west Passage area offer a relatively sheltered potential source of sand that could be sourced by dredging at significantly lower cost using the existing Port Board dredge than for offshore sources. These are shown in Figures 3.3 and 3.4 and include the following areas, with estimates of available quantities provided by Council:

- Lighthouse Beach (approx 150,000 m³);
- Puddney Ground (up to approx 17-25,000 m³);
- SW Passage south of causeway (30-45,000 m³);
- SW Passage north of causeway (approx 25,000 m³); and
- Channel between original Griffiths and Rabbit Islands (90,000 m³).

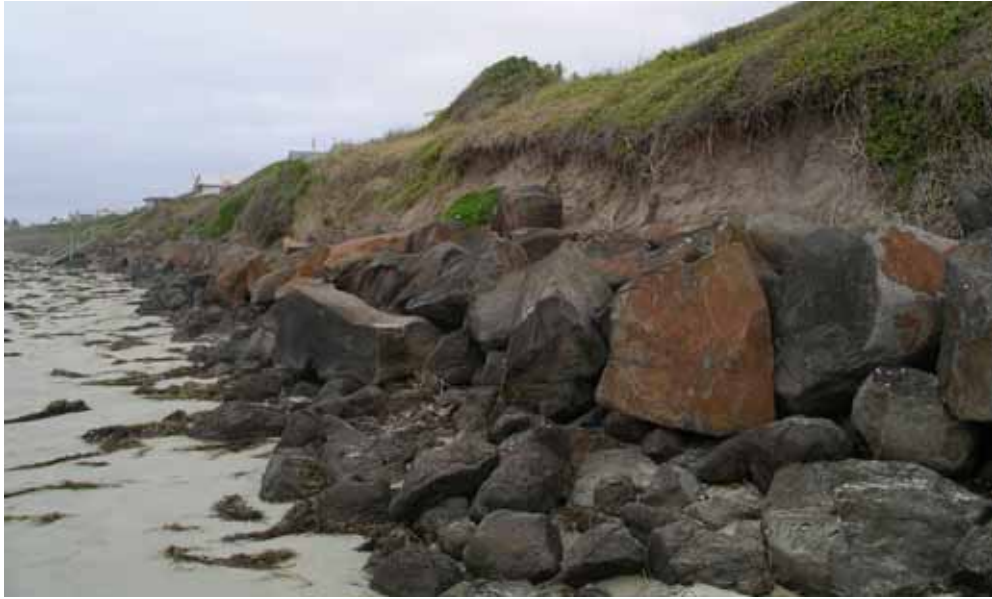
Figure 4-1 Section of Seawall of Sub-Standard Construction

- The existing seawall appears robust in some sections but requires reconstruction to bring it up to an acceptable standard to withstand future wave attack along other parts. Superficial inspection of the seawall suggests that it is generally deficient with respect to provision of adequate filter layers, thus allowing progressive loss of sand from behind the structure. However, many years of repeated maintenance by 'topping up' the armour rock appears to have established a reasonably robust structure along all but the most northern section, north of around Manifold and Connolly Streets.

While an upgrade to the construction at the northern end (Figures 4-1 and 4-2) and continued maintenance along the entire length are needed, the design/construction standard required will depend to an extent on the degree of beach restoration undertaken, itself providing some protection.

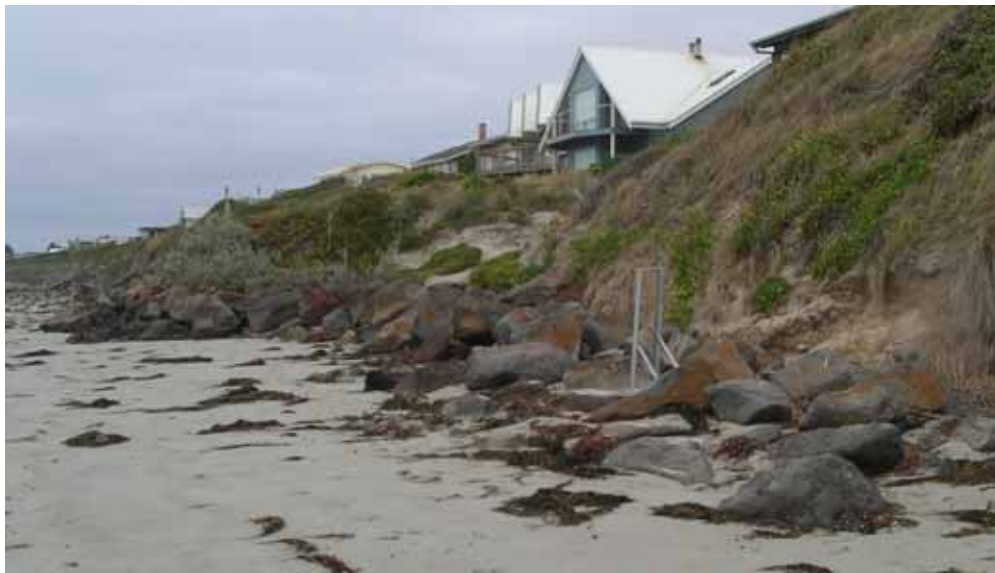
Figure 4-2 Northern End of Seawall of Sub-Standard Construction

The northern end of the seawall presently is in poor condition and requires complete reconstruction to a suitable design standard. As well, provision is needed to end the seawall at the northern end of the
