PORT FAIRY

EAST BEACH
Coastal Erosion

Engineering & Feasibility

Prepared For: Moyne Shire Council

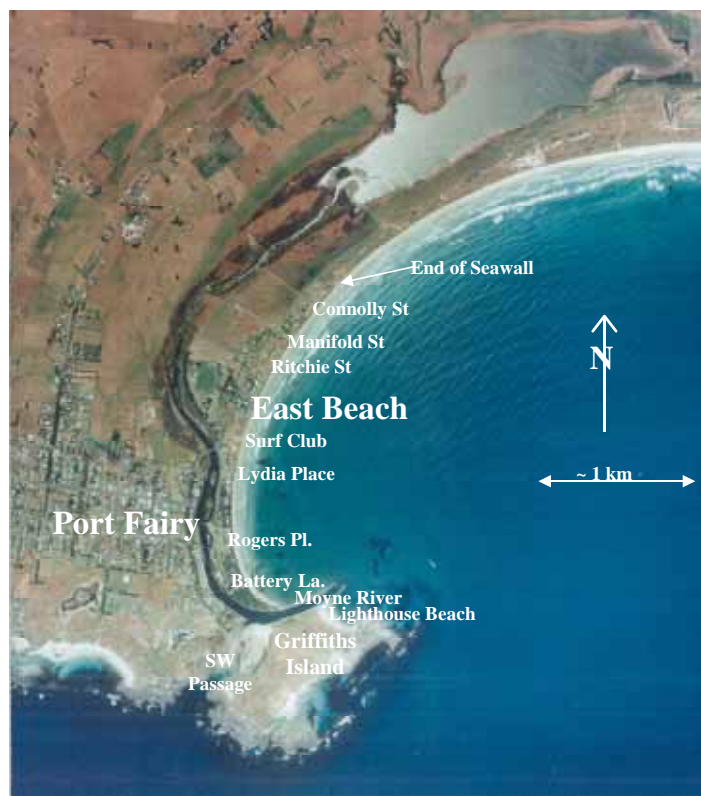
Figure 1-1 East Beach

East Beach at Port Fairy is located at the southern end of Port Fairy Bay (Figure 1-1). It faces southeast and thus is directly exposed to southeast winds prevailing during summer months, while receiving some protection from heavy southwest winds during winter. The beach is backed by a substantial dune over 8 metres in height. The beach is bound to the south by the training walls of the Moyne River entrance and sweeps in a smooth curve to Reef Point at its north-eastern end.

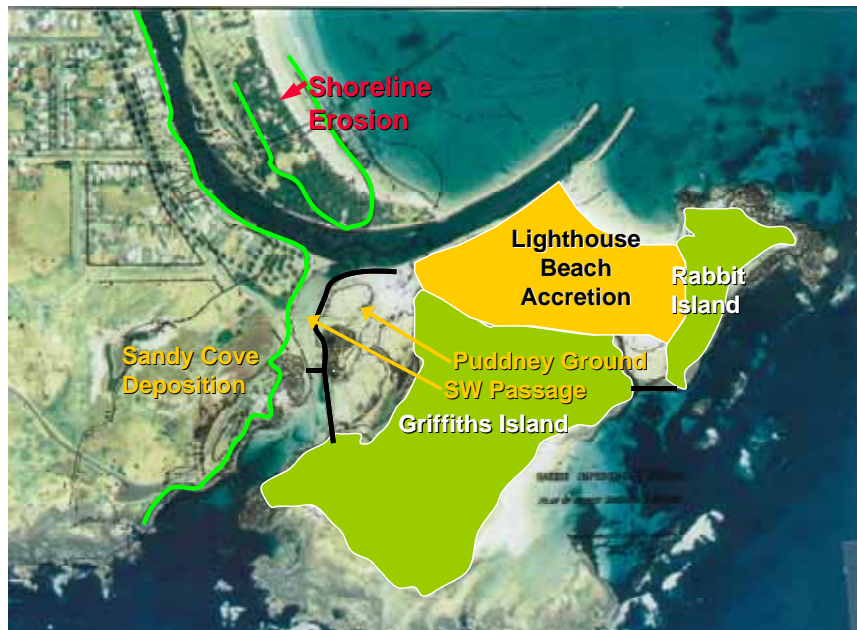
Figure 2-1 Original Shoreline and Sand Deposition Areas at Griffiths Island

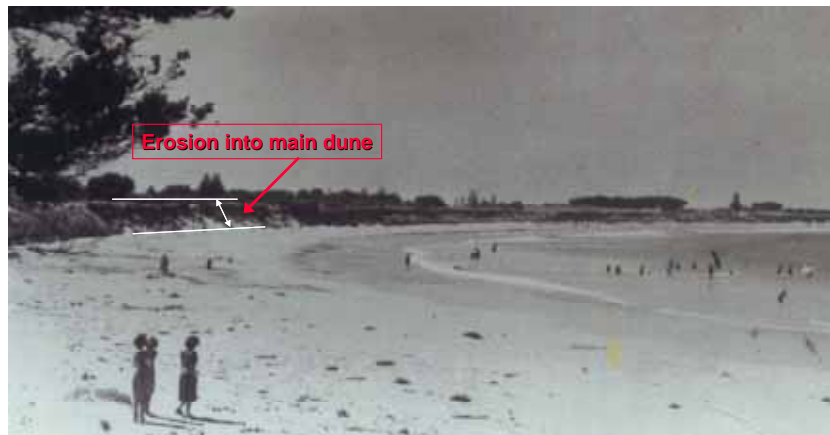
Figure 2-4 Erosion into East Beach Main Dune Approx 1930

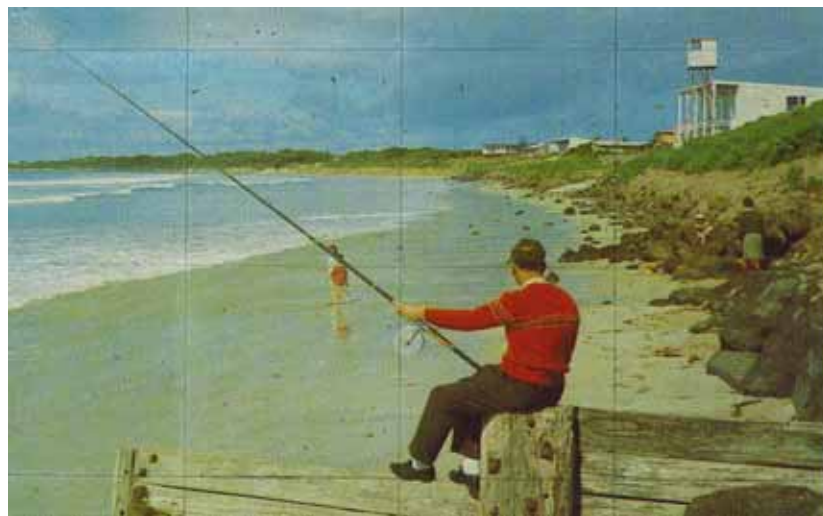
Figure 2-5 Commencement of Rock Seawall Construction at Surf Club (1965)

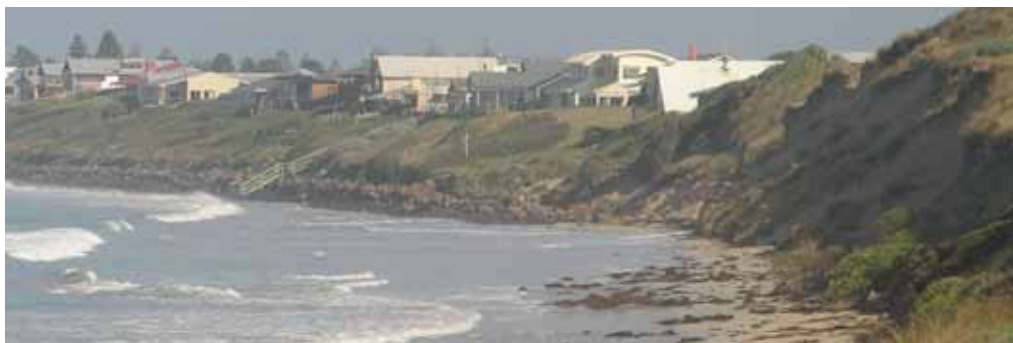
Figure 2-6 Rock Seawall Extended Past Connolly Street (2006)

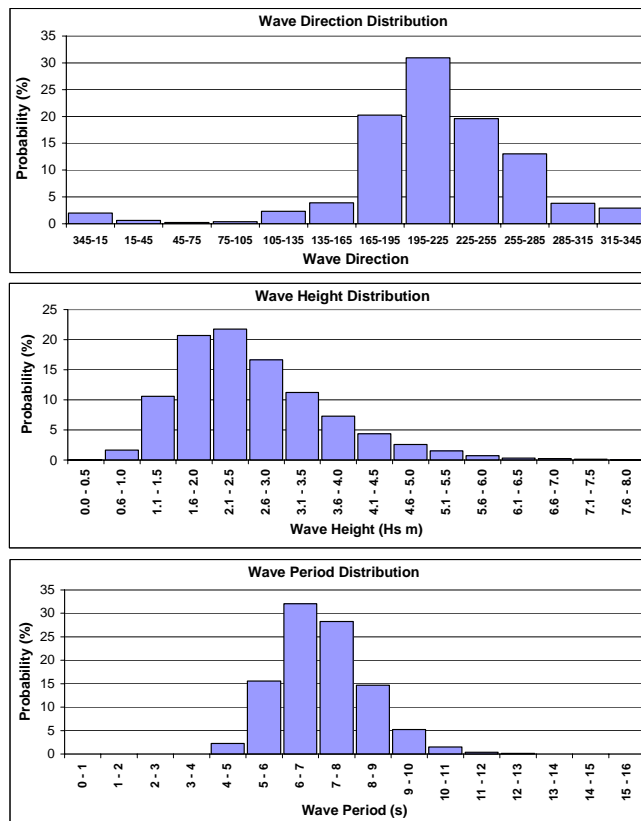
Figure 2-7 Wave Characteristics in Deep Water South of Port Fairy

The data and modelling has confirmed the dominance of southwest waves in the region and the expected general processes of wave propagation, generation of currents and patterns of longshore sand transport, including (for example) that the wind contributes to the currents and sand transport (Figures 2-9 and 2-10). However, it shows that the processes are complex and difficult to model

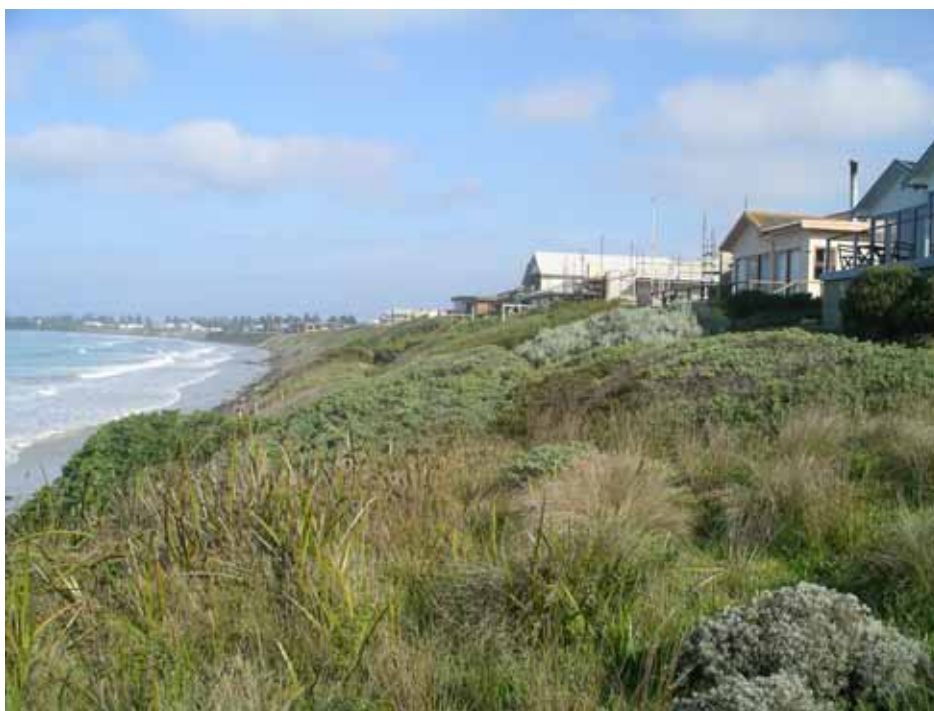
Photo 1: Development located on dune in erosion prone area

Clearly the residential development is located on the dune too close to the sea. It must be recognised that some options aimed primarily at protection of property located within the erosion prone area (eg seawall construction) may be detrimental to the beach, as evidenced by the present diminution of the area of usable beach, particularly at high tide. Further, some options that restore and/or maintain the beach (eg nourishment) provide a measure of protection to the property. Invariably, overcoming an existing problem of beach loss or degradation is very costly.

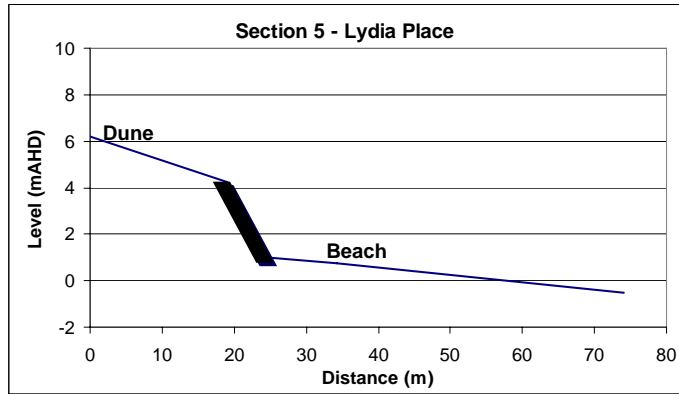
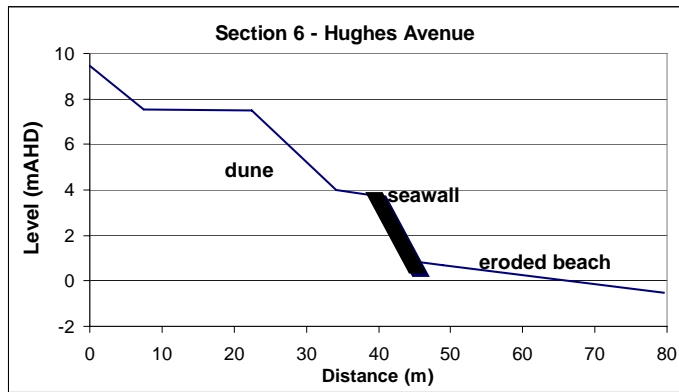
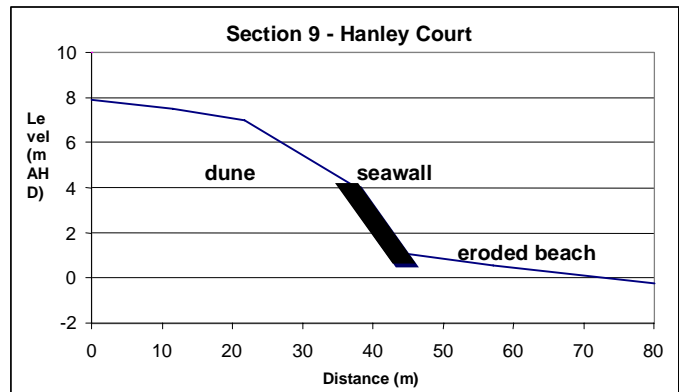
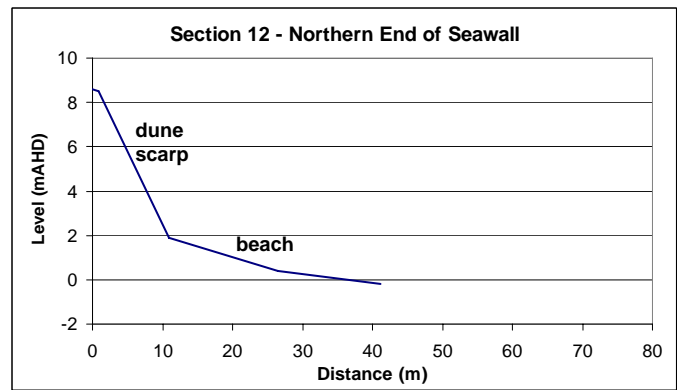
Figure 3-1 Typical Survey Cross-Sections along East Beach

The residential and road development along East Beach has been under direct threat from erosion. A seawall was constructed during the 1960s and subsequently to protect the development. Typical beach and dune cross-sections along East Beach are shown in Figure 3-1.

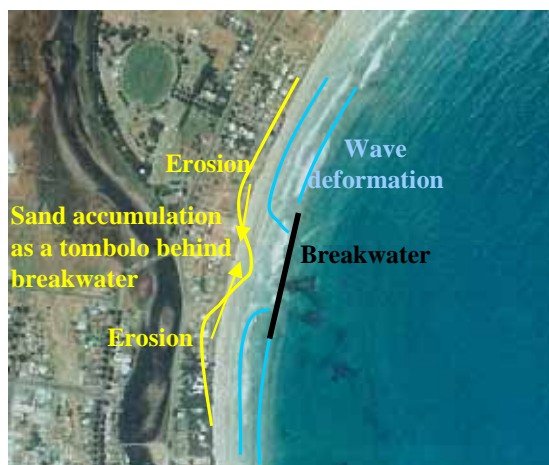
Figure 3-3 Typical Breakwater Behaviour

Offshore breakwaters and submerged reefs are robust structures constructed offshore from the beach and function by altering the height and direction of waves reaching the beach and/or the pattern of currents affecting sand transport such that the beach is built up in particular areas. They are typically constructed parallel to the shoreline, diffracting the approaching waves and creating a sheltered zone in which sand moving along the coast under longshore transport processes is trapped and accretes, forming a salient or tombolo (Figure 3.3). As for groynes, this trapping effect starves the downdrift beaches of sand, leading to erosion there.

Offshore breakwaters are typically surface piercing structures, which are capable of withstanding and blocking wave attack. The build up of sand and reduced wave heights provide protection against storm erosion and the stabilising effect can reduce long term recession rates behind and updrift of the structures. The extent of influence is dependent on the length, spacing and distance offshore which would need to be considered in optimising the design of such structures. Construction of offshore breakwaters is also generally more difficult and expensive than shore connected structures.

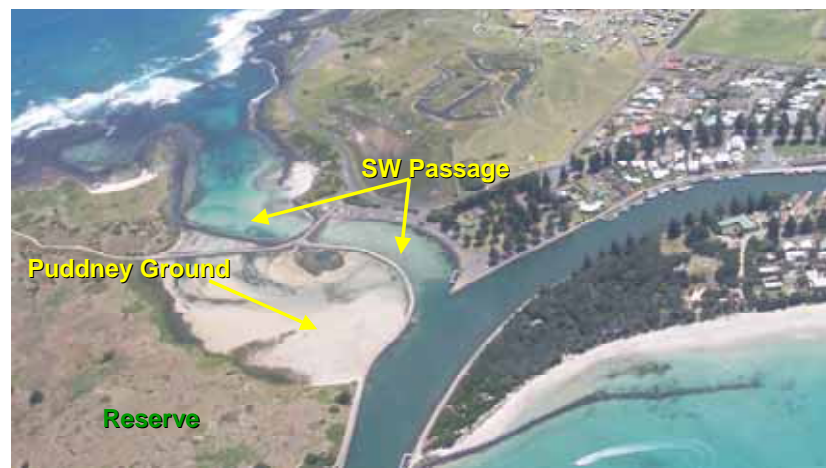
Figure 3-6 SW Passage and Puddney Ground Sand Deposits

- Lighthouse Beach (approx 150,000 m³);
- Puddney Ground (up to approx 17-25,000 m³);
- SW Passage south of causeway (30-45,000 m³);
- SW Passage north of causeway (approx 25,000 m³); and
- Channel between original Griffiths and Rabbit Islands (90,000 m³).

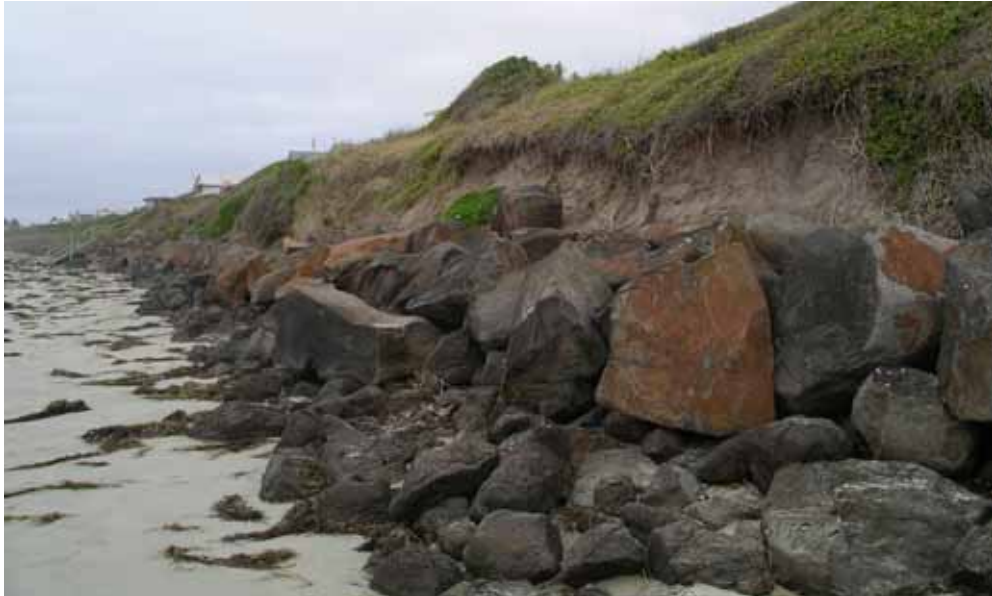
Figure 4-1 Section of Seawall of Sub-Standard Construction

While an upgrade to the construction at the northern end (Figures 4-1 and 4-2) and continued maintenance along the entire length are needed, the design/construction standard required will depend to an extent on the degree of beach restoration undertaken, itself providing some protection.

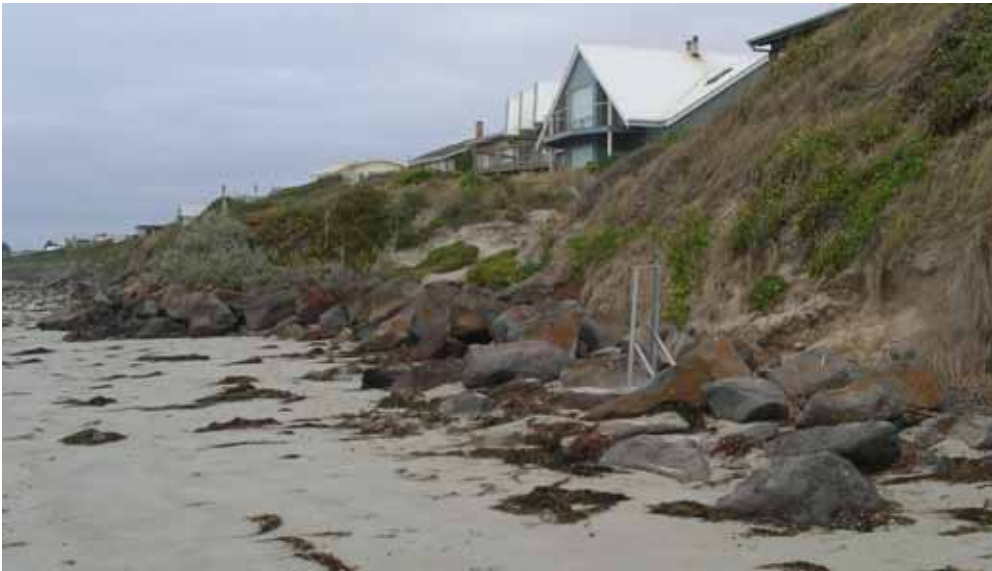
Figure 4-2 Northern End of Seawall of Sub-Standard Construction

The northern end of the seawall presently is in poor condition and requires complete reconstruction to a suitable design standard. As well, provision is needed to end the seawall at the northern end of the

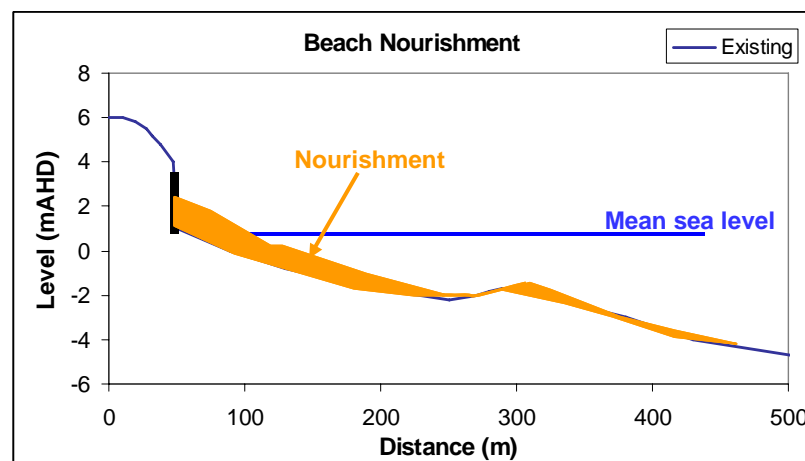
Figure 4-5 Distribution of Sand Across the Nearshore Profile (Conceptual Only)

- the best estimate of the quantity of sand lost from the beach due to the river entrance works in the 1800s and early 1900s is approximately 500,000 cubic metres and some re-adjustment in the beach alignment towards a new equilibrium with the altered sand supply regime has most probably occurred subsequently; and
- that quantity represents 150 m³/m, a triangular fillet of sand 2 metres high at the beach grading to zero at a distance of 150 metres offshore.

While this provides an impression of the quantity involved, it must be recognised that the sand placed on the beach will be integrated into the natural processes of erosion from the beach during storms and subsequent gradual return to the beach by the swell waves. Thus, the sand will be distributed both alongshore and across the profile out to water depths of at least 6-8 metres (Figure 4-4) and the realistic initial benefit of a nourishment quantity of 300,000 m³ in terms of beach width will probably be around 20 metres.
