## WORK PLAN SPECIFIC CONDITIONS

## Work Authority WA1478 Work Plan (WA) PLN-001732

Project Name	Mount Shadwell Scoria Quarry
Plan Description	<p>Mount Shadwell Scoria Quarry is located on Lots 1, 2 &amp; 4 on the lower northern slopes of Mount Shadwell approximately 2.5km north of Mortlake. (Please refer to Location and Regional Plans). The site, a farming property is reasonably isolated in an area of grazing and cropping properties, with the closest residence being the owners. (Please refer to Receptor Plan for details). Lots 1, 2 &amp; 4 are intensely cultivated and are devoid of native vegetation. Lots 1 &amp; 2 are area of approximately 7.3 ha. Approximately 2 ha of Lot 1 has been historically excavated under the previous ownership. Lot 4, an area of 24.3 ha is in the same ownership, as Lots 1 &amp; 2 and lies immediately west of Lot 1. (Please refer to Site and Location Plans). The material to be quarried is volcanic scoria. Waste rock does not appear to be present., all of the extracted scoria will be processed. (Please refer to Douglas Partners Geotechnical Report, Sections 2 and 4). The intended use of the product is for general road and farm track base.</p> <p>A bulldoz

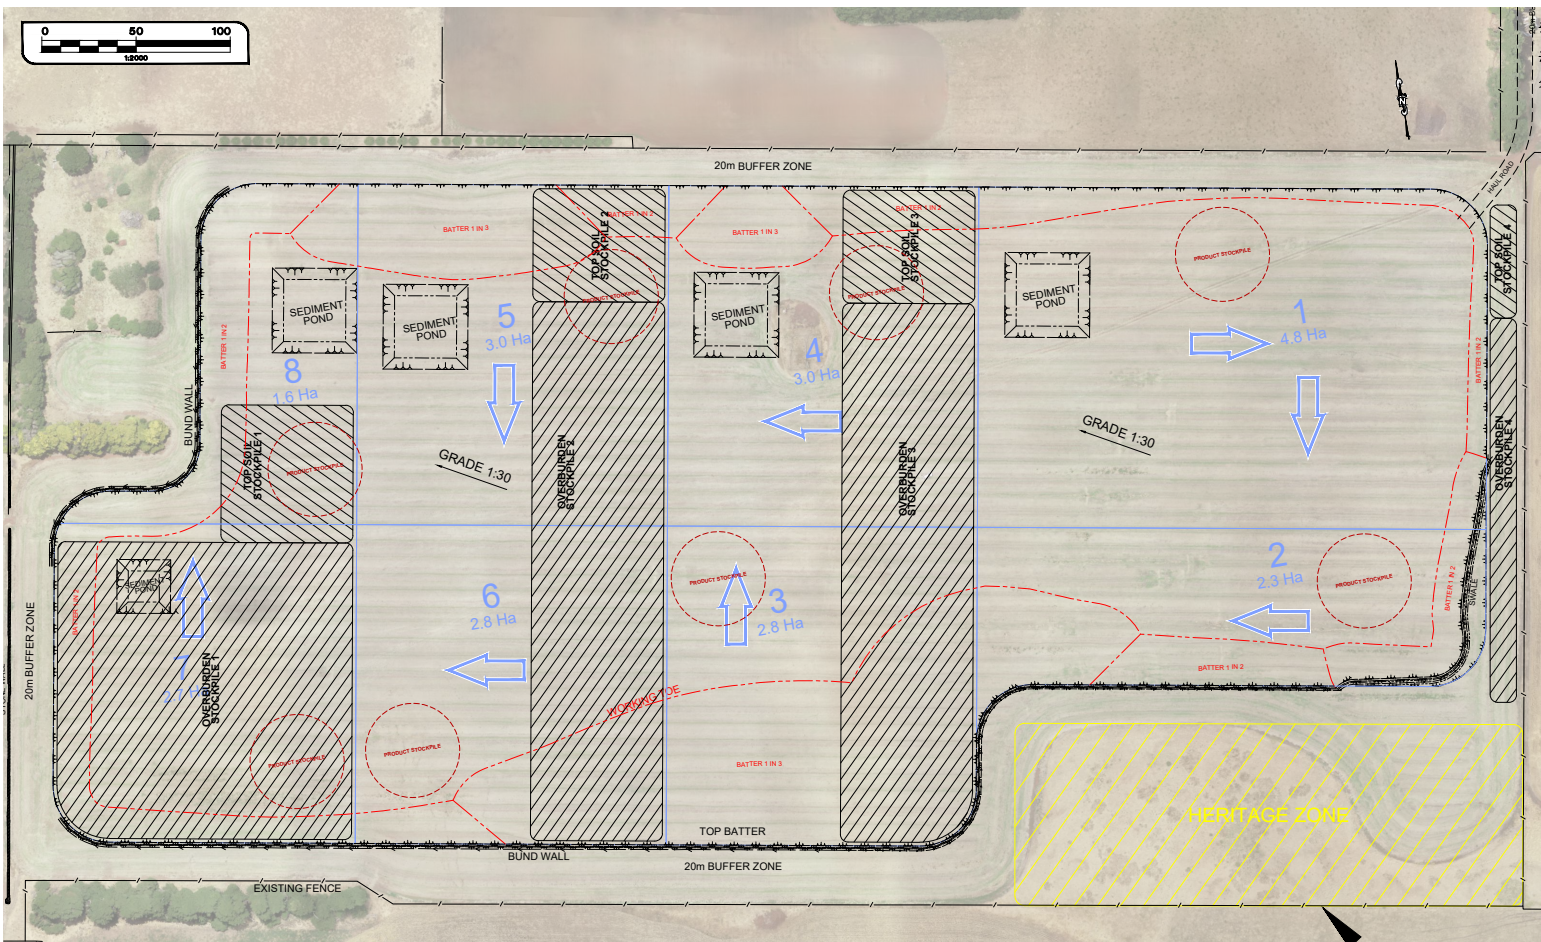
Survey : C.T.		29/12/2020
Design :		June 2023
File No. : Mt Shadwell Quarry 20-12-20 Working Juke		
Scale :		1:2000 (A3)
Sheet	PLAN NO.	
<b>11/27</b>	<b>215072</b>

**WA1478 Mt SHADWELL  
SCORIA QUARRY  
WORKING SURFACE MODEL  
MORTLAKE  
VICTORIA**

- Scoria will be excavated by bulldozer pushing downslope with rippers and stockpiled on the quarry floor for crushed and screening.
- A portable crusher will be bought on site as required.
- Finished product will be stockpiled on the quarry floor for loading into customer trucks.  
(Please refer to Work Plan sheets, 1/27 & 11/27).
