# Attachment E

## Existing Conditions Site Plan and Photographs

### 23 Boundary Road, Mortlake VIC 3272

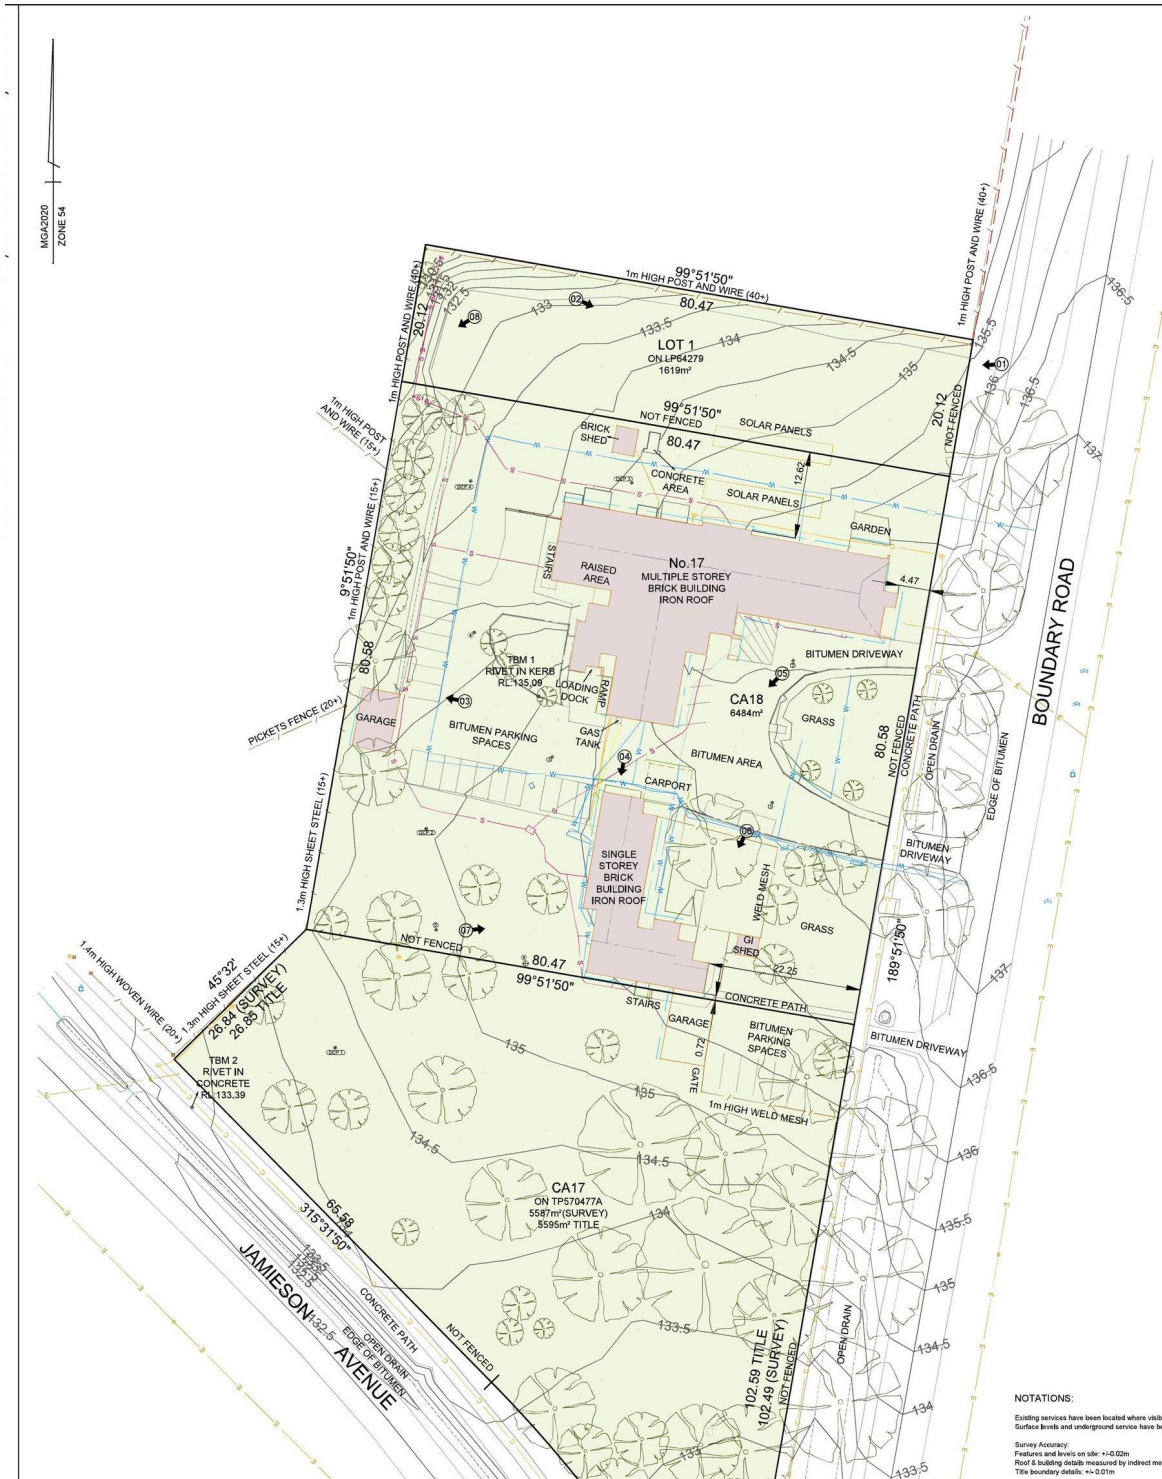
### 3. Existing Conditions Site Plan

**Source:** Detailed Land Survey by Swanson Surveying Pty Ltd. Plan Reference 12268 RE01V1, Scale 1:400, dated 1 March 2023.

**Photo location key:** The numbered circular markers on the survey plan (01 to 08) indicate the location and direction from which the corresponding photographs in Section 4 of this Attachment were taken.

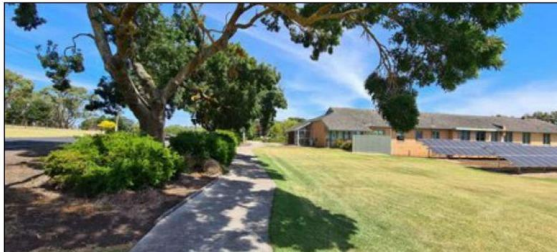
**Photo 1**

Northern entrance to the hospital precinct from Boundary Road. View looking west showing the established landscape, concrete path, mature canopy trees, garden beds and the multi-storey brick hospital building in the middle distance with solar array.

- Multi-storey brick hospital building (No. 17 on the survey) with iron roof, located centrally on CA 18. The building includes a loading dock, raised area to the western elevation and an external stair (Photos 1 and 2);
- Single-storey brick building with iron roof located immediately south of the hospital. This building, with verandah entry and weatherboard gable, is the subject of the proposed change of use to Childcare Centre (Photos 4 and 8);
- Carport between the two buildings, providing covered vehicle access to the hospital (Photo 3);
- Brick shed on the northern boundary (Lot 1) (Photo 6 background);
- Galvanised iron shed at the southern end of CA 18 adjacent to the southern access driveway.

The site features an established landscape of significant maturity. Mature trees of varying species are scattered across the central and southern portions of the site, particularly along boundaries and within the southern open ground (CA 17). The landscape is well maintained, with formal garden beds along the northern (Boundary Road) frontage and around the hospital building entrance (Photos 1 and 5).

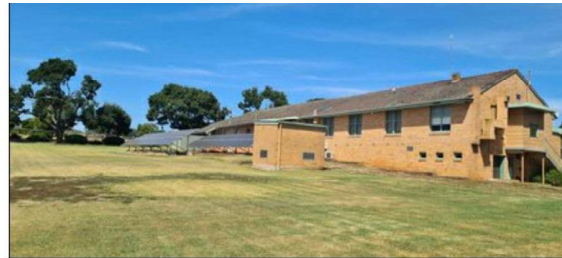
**Photo 2**

Multi-storey brick hospital building (No. 17 on the survey) viewed from the south-west, showing the southern elevation, iron roof, solar array adjacent and open grassed area to the south. Established trees along the western boundary.

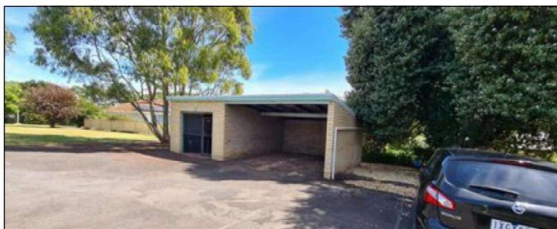
**Photo 3**

Carport and existing bitumen parking spaces located between the hospital building and the former day centre. View looking east. The pickets fence (20+ years old) on the western boundary is visible to the left.

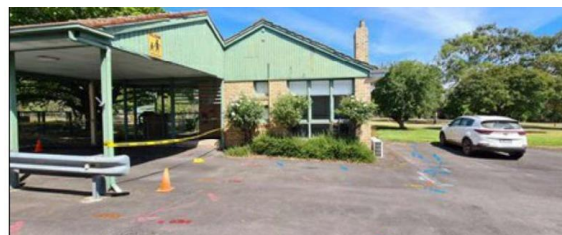
**Photo 4**

Subject building, single-storey former day centre with verandah entry, weatherboard gable end and brick walls. The dedicated southern bitumen car park is shown in the foreground, proposed to serve the Childcare Centre family drop-off and pick-up.

- A primary northern bitumen driveway from Boundary Road accessing the hospital building's main entry, loading dock and parking;
- A southern bitumen driveway from Boundary Road accessing the dedicated car park serving the former day centre building (Photo 4). This is the access point proposed to serve the Childcare Centre.

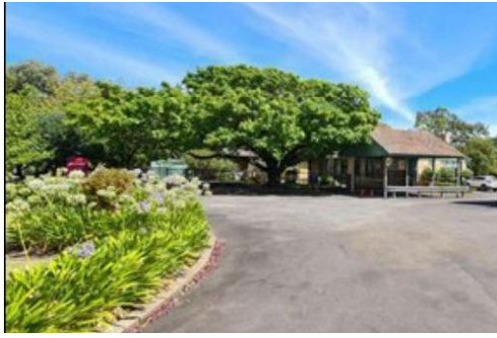
**Photo 5**

Western access from Jamieson Avenue showing mature canopy tree, formal garden beds and the verandah of the former day centre in the background. The sealed bitumen surface in the foreground connects to the broader precinct car parking.

The site contains formed bitumen parking arrangements adjacent to both buildings, with the southern car park containing approximately 25 marked spaces directly adjacent to the former day centre. A further sealed bitumen driveway connects through to Jamieson Avenue on the western boundary (Photo 5).

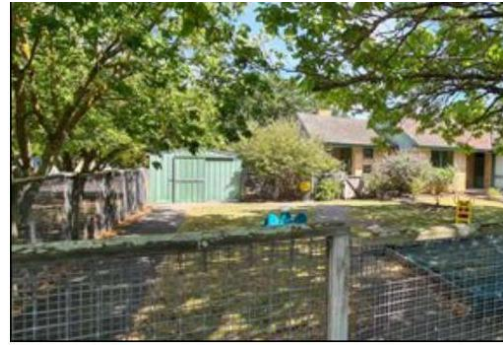
**Photo 6**

Rear of the day centre building looking north towards the brick shed and hospital. The existing 1 metre high weld mesh fence forms an enclosed area suitable for adaptation as part of the proposed 485 square metre outdoor play area.

- North boundary: 1 metre high post and wire fence (40+ years old);
- East boundary (Boundary Road): no fencing along most of the alignment; sections of post and wire fence;
- South boundary: not fenced;
- West boundary (Jamieson Avenue): 1.3 metre high sheet steel fencing (15+ years old) and pickets fence (20+ years old) at the rear of the southern car park (Photo 3);
- Internal: 1 metre high weld mesh fence enclosing a previous outdoor area south of the day centre building (Photo 6).

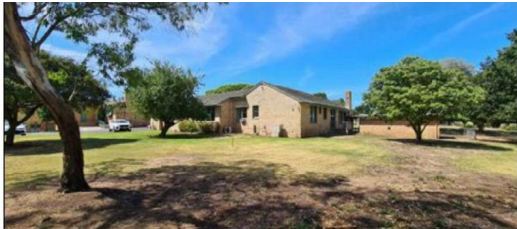
**Photo 7**

View from the southern open ground (CA 17) looking north towards the rear of the day centre building. Established mature trees, open grassland and the brick wall of the day centre are visible.

The southern parcel (CA 17) is open grassland with scattered mature trees, providing an attractive landscape setting and visual buffer between the developed precinct and Jamieson Avenue (Photos 7 and 8).

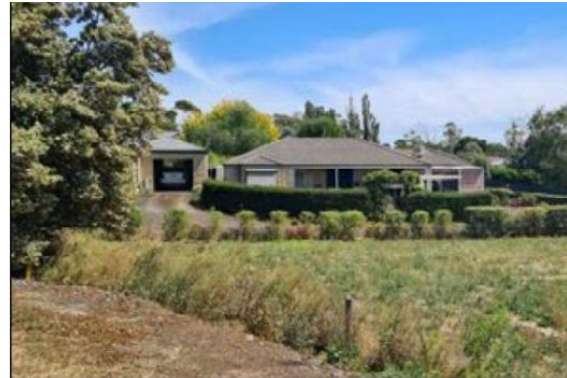
**Photo 8**

View of the day centre and grounds from the south. The single-storey building footprint, established landscape, and the residential properties across Boundary Road (Rural Living Zone) are visible in the background.

- North: Established single-storey residential properties within the General Residential Zone fronting Boundary Road and Waters Lane;
- East (across Boundary Road): Rural Living Zone with established residential dwellings on larger lots (Photo 8 background);
