EAST BEACH SEAWALL

WORKS PREPARATION

SEAWALL ASSESSMENT & DESIGN CONCEPTS

Moyne Shire Council

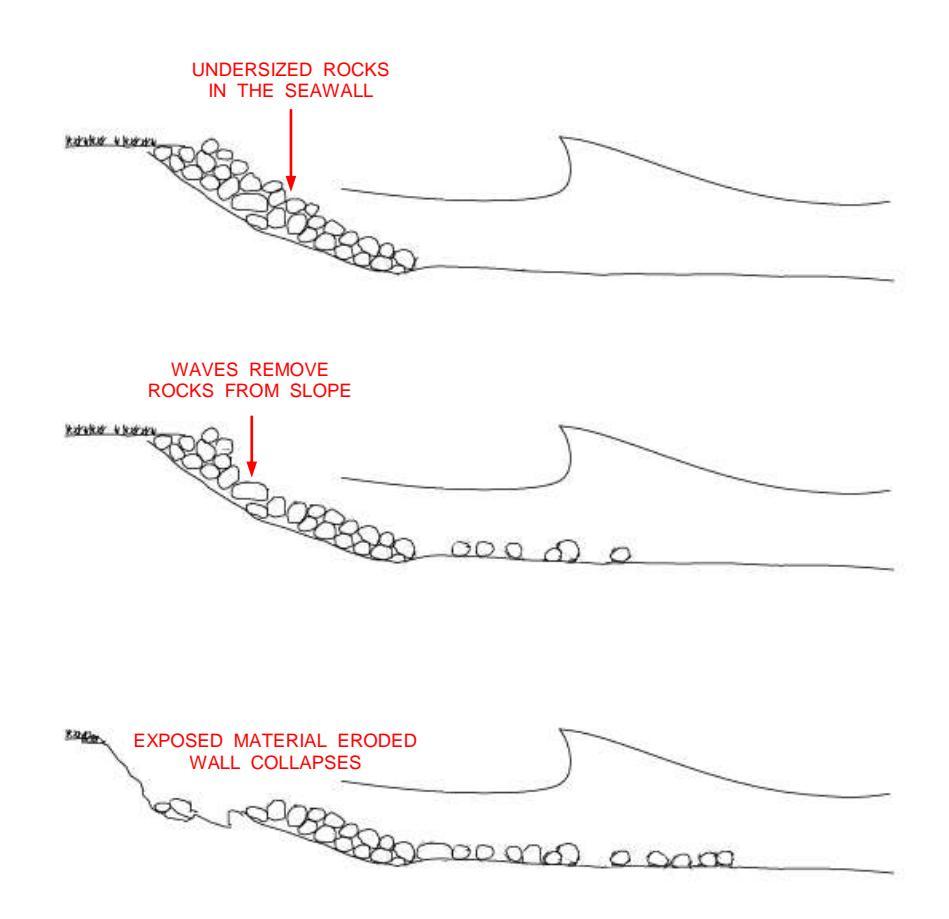
Figure 3 : Damage / Failure Due to Erosion of the Armour Layer

This type of damage is illustrated conceptually in Figure 3. It is instigated when the rock armour on the front face of a seawall is not able to accommodate the forces applied by the larger waves in the sea state as they wash against the slope. It can be due to a number of deficiencies:

- the rocks themselves are too small (or they have broken down over time into smaller sizes);
- the placement density is poor (such that rocks are very loosely placed and easily removed);
- there is insufficient rock coverage on the underlying slope (allowing waves to wash out the material in the underlying bank slope);
- the front slope of the wall is too steep (allowing any loose rocks to be easily dislodged by waves and to roll down off the slope).

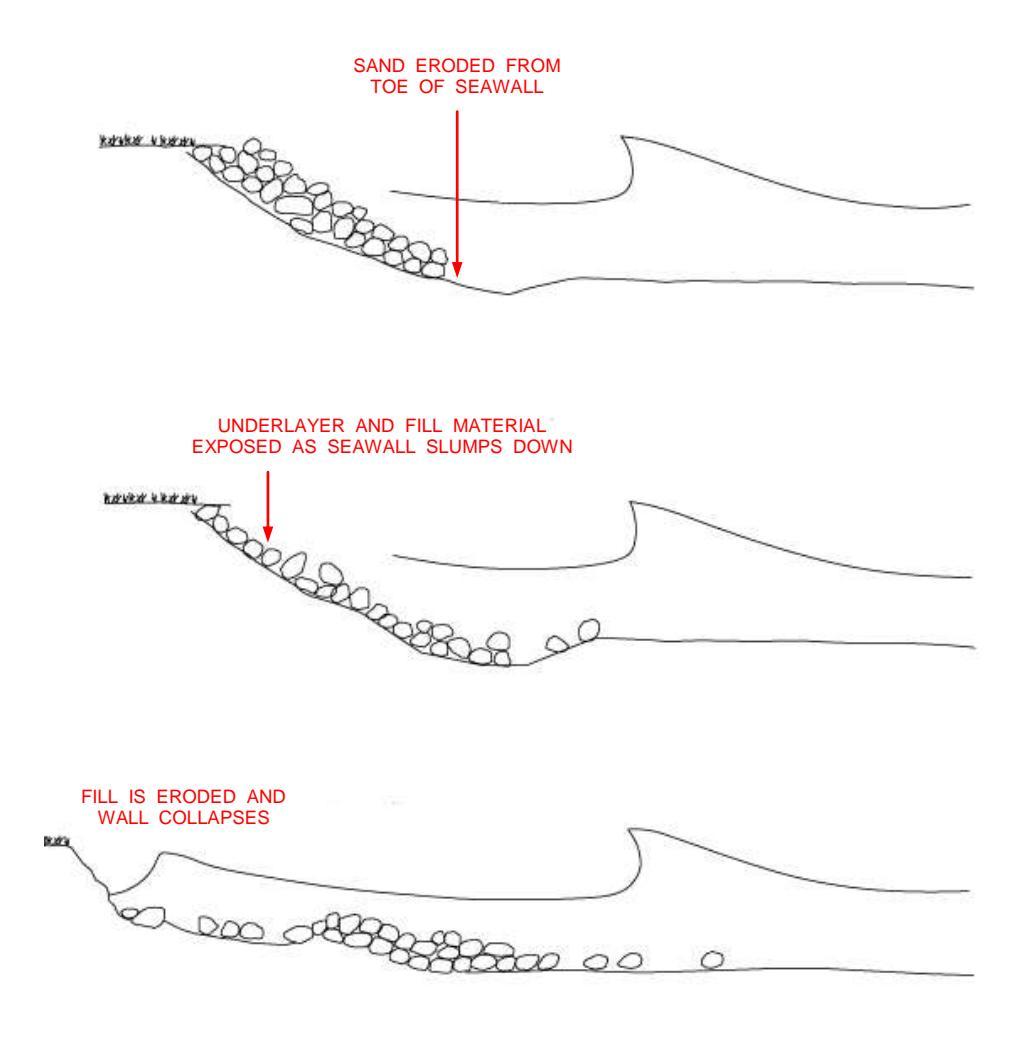
Figure 4 : Damage / Failure Due to Undermining

The high levels of turbulence generated as incoming waves encounter a seawall can be sufficient to initiate scour at the toe of the seawall. If the seawall is founded at a high level, then this scouring of material in front of it may undermine the foundation of the seawall itself. This failure mechanism is illustrated conceptually in Figure 4.

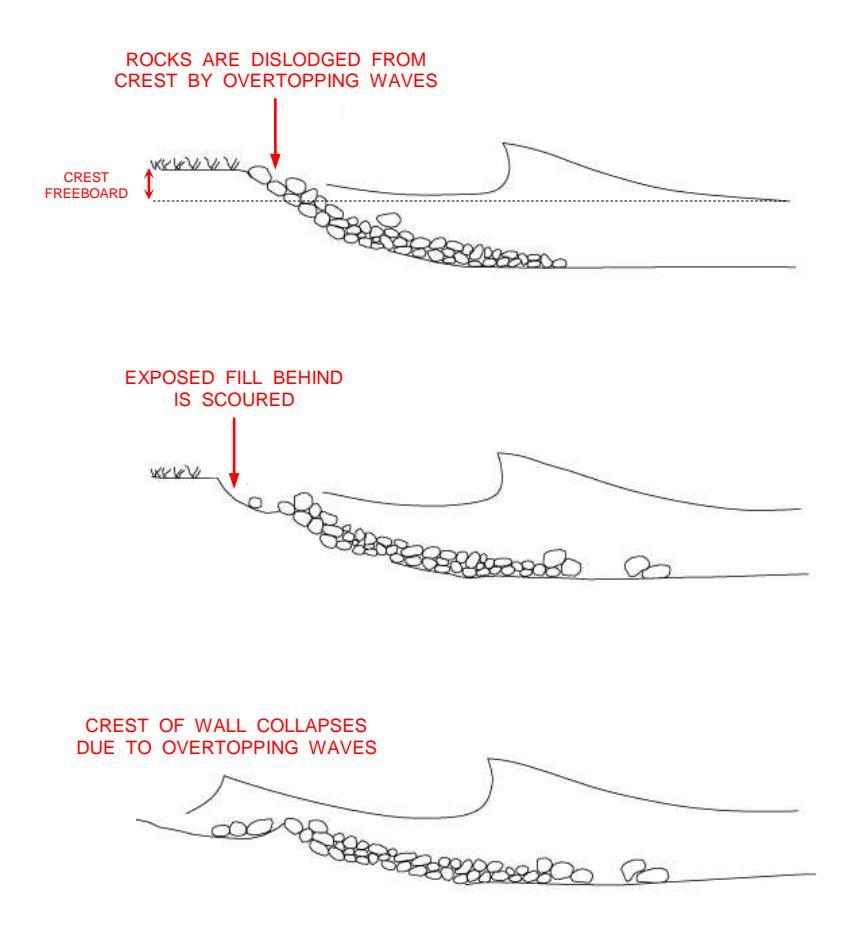
Figure 5 : Damage / Failure Due to Overtopping

Scouring of the material supporting the crest of the wall results in collapse of the top section of the armour layer back into the scour hole. This effectively reduces the height of the seawall, thereby increasing the occurrence and severity of subsequent green water overtopping, leading to greater scour, leading to even greater overtopping, etc. This progressive damage can rapidly lead to failure of the seawall. The process is shown conceptually in Figure 5.
