Avenues of Honour - Tree Management Study

Moyne Shire Council

FINAL REPORT

MARCH 2017

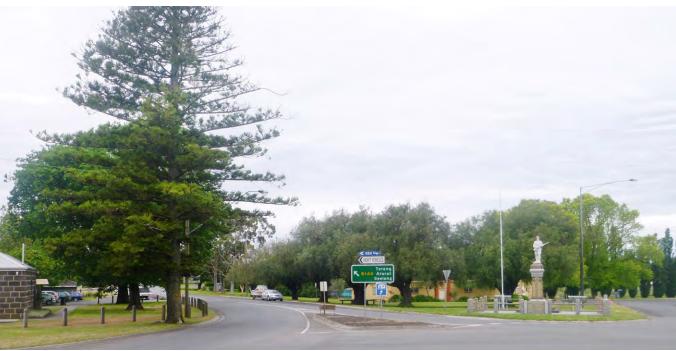
The Peace Tree on the left and the memorial statue on the right, at Mortlake

At Market Square, corner of Shaw and Officer Streets, there is the Peace Tree, an Araucaria heterophylla (Norfolk Island Pine) in Celebration of Peace. The tree is in only fair condition, there is scar damage to the base of the trunk against the kerbline (car damage as right on the kerbline).

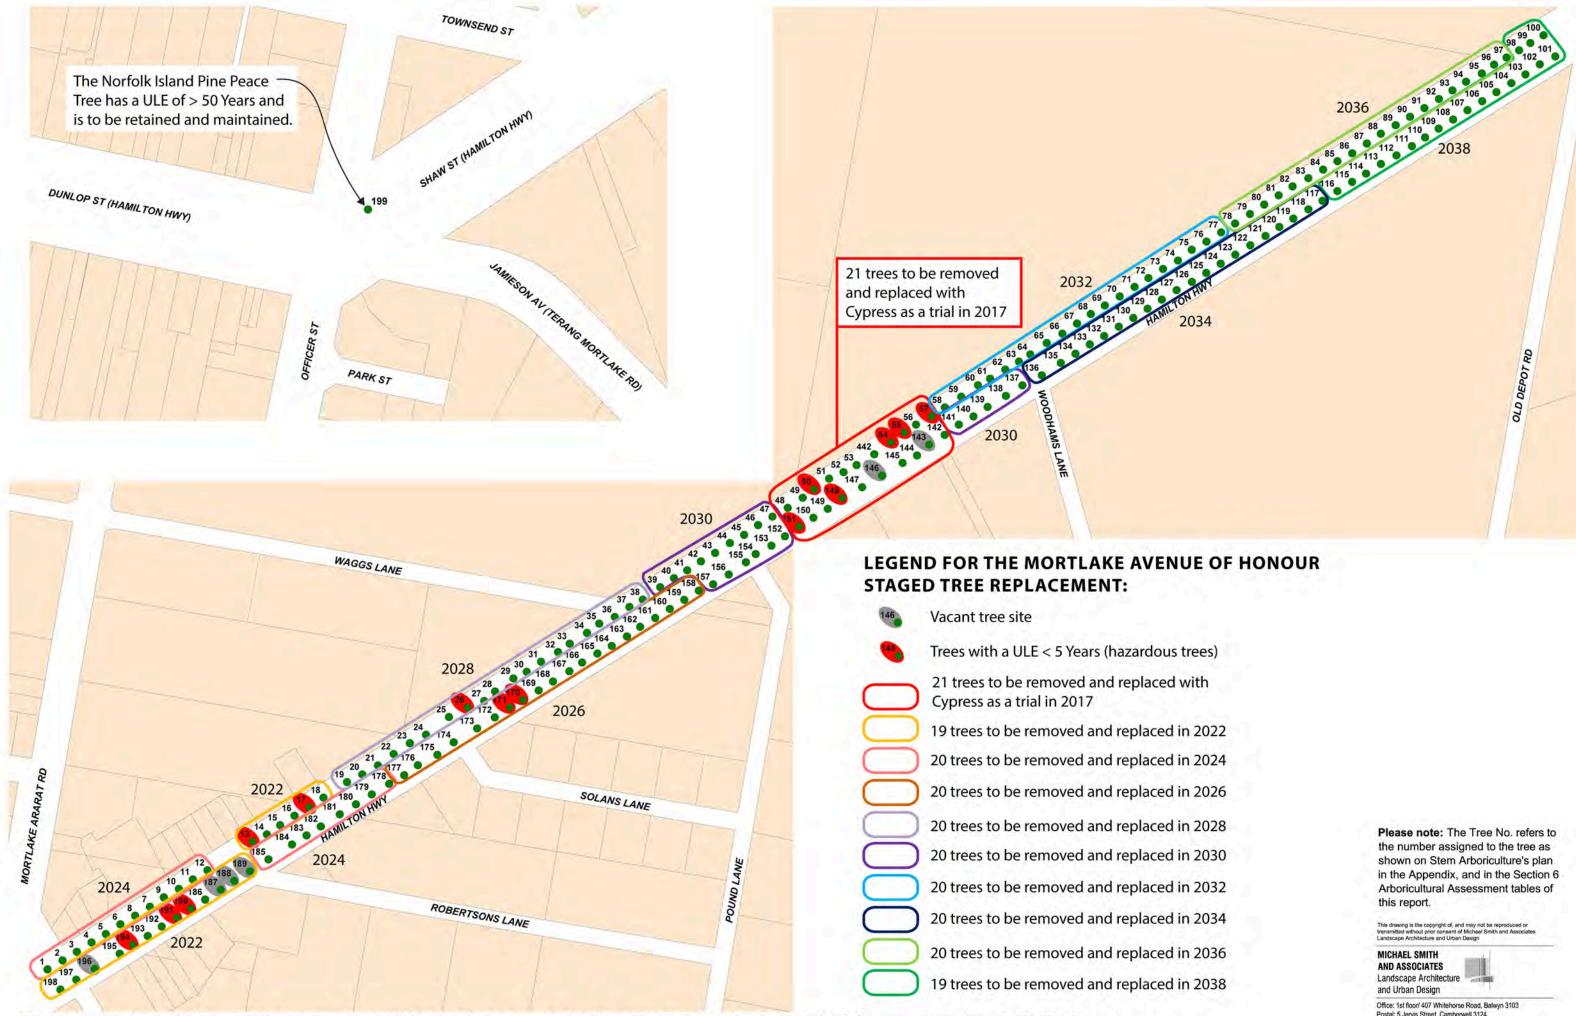
MORTLAKE TREE REMOVAL AND REPLACEMENT STRATEGY AVENUES OF HONOUR TREE MANAGEMENT STUDY MOYNE SHIRE COUNCIL

Recommended action of removal and replacement of a block of 19 trees in 2038 coded in dark green.
