**East Beach Coastal Erosion
Engineering and Feasibility
Study**

Report ref:
203054/001
29 July 2010
Revision 6

Peer Review

**Department of Sustainability
and Environment**

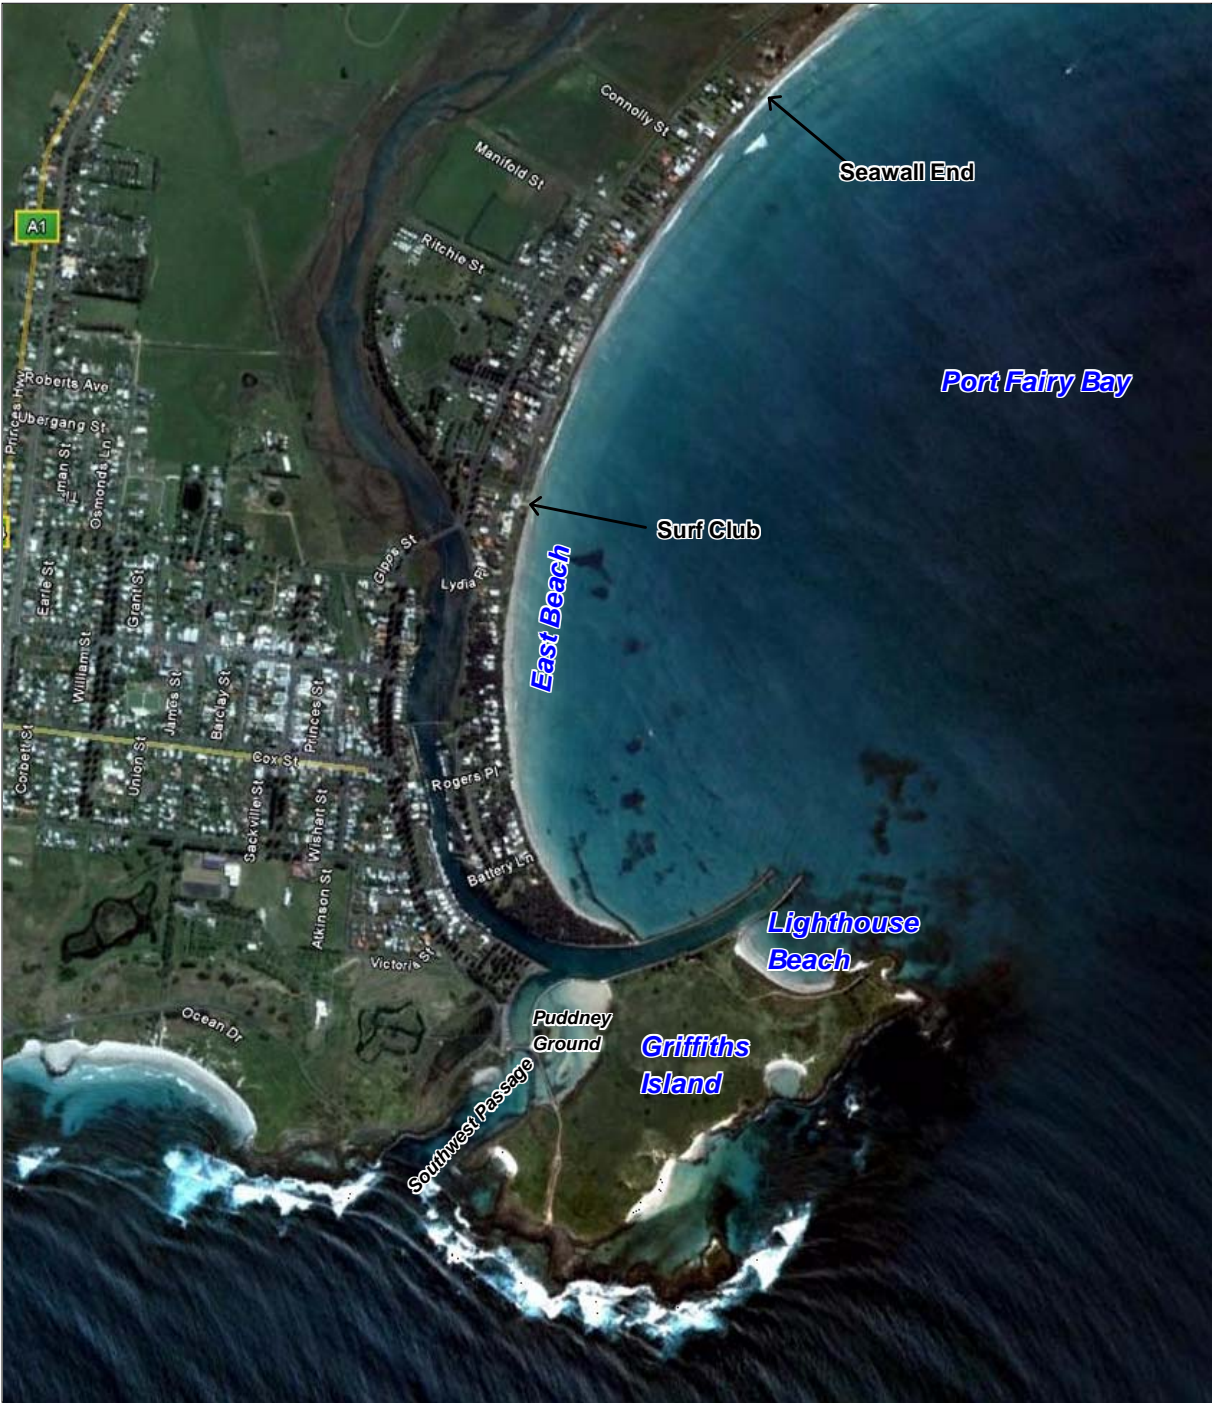
Figure 1 East Beach Port Fairy – Overview

East Beach is a valuable asset providing coastal recreation opportunities for the local community and visitors to Port Fairy. There are numerous public and private assets located along the coastal dune system and on-going erosion has led to a loss of sand from the beach system and is threatening these assets. An overview of the study area is provided below in Figure 1.

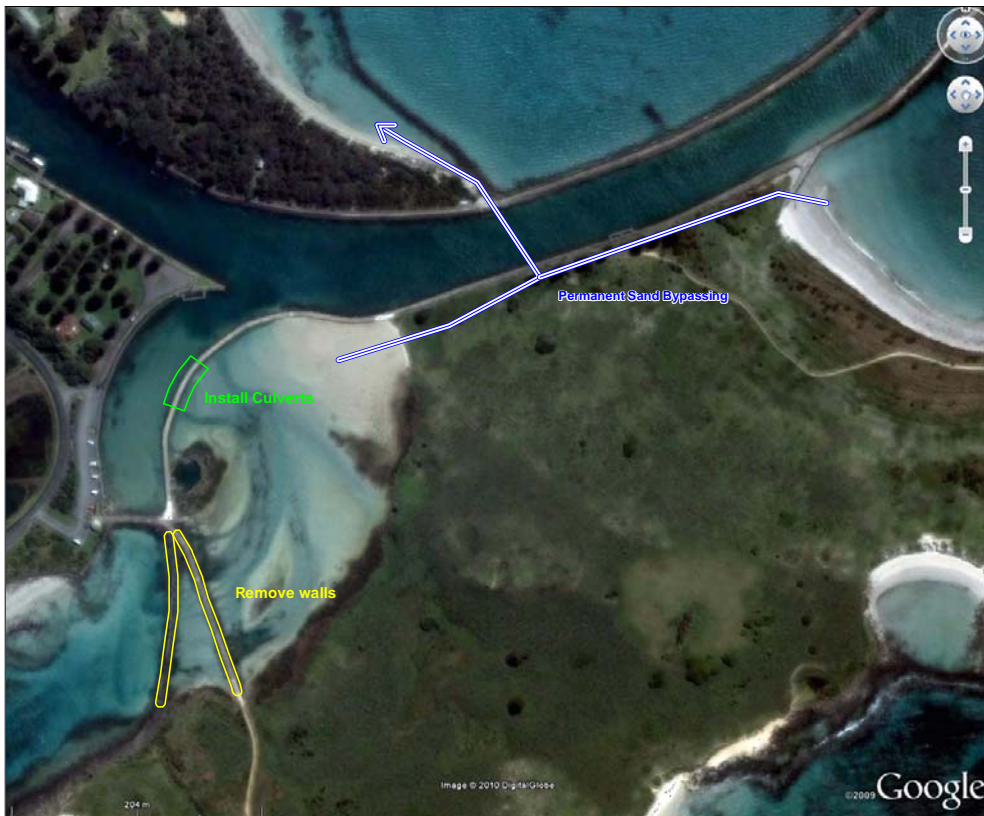
Figure 4 Alternative Approach to Sand Management in Southwest Passage

Nevertheless, it may be possible to utilise the SW Passage as a sand capture area without the adverse impact of sediment deposition in Moyne River. The following alternative concept is proposed (illustrated in Figure 4), and while not fully assessed, is considered to provide a similar sand capture opportunity without increased maintenance dredging burden.

The concept utilises the Puddney ground as a sand capture area for sand that migrates into the SW Passage. Rather than removing the seawall that connects the Island with the mainland, the 2 southerly causeways are removed (perhaps to be replaced by a higher level walkway on piles). Waves and sand would propagate up the SW Passage into the Puddney Ground basin, where the sand would deposit. The excess wave wash is discharged via culverts (invert about MSL) such that there is a net one-way through flow of water. The existing dredge could be modified and used to capture the deposited material to be discharged on the northern side of the entrance. As an alternative, a permanent by-passing system could be established in the longer term, and its size based on monitoring of initial sand capture and transfer volumes. A shared pump station could facilitate regular sand by-passing from both the Puddney Ground and Lighthouse Beach.
