Bant's Quarries Tuff and Scoria Quarry 98-100 Hopkins Falls Road, Panmure

Work Authority 32 Pln 001756

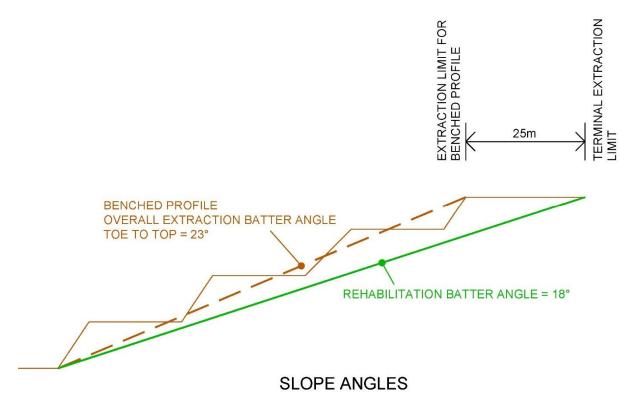
PROFILE THROUGH HIGHLY/SLIGHTLY WEATHERED BRECCIA

The benched profile produces an overall batter slope angle of 23°.

The benched profile will be discontinued when the top of the cut batter is 25m inside the terminal extraction limit. Extraction will then transition to a batter slope angle of 18° (1V:3H). This will ensure that there is no overcut requiring backfill to form the rehabilitation batter. The slope of the terminal extraction batter will be the same as the rehabilitated batter with no reshaping required.

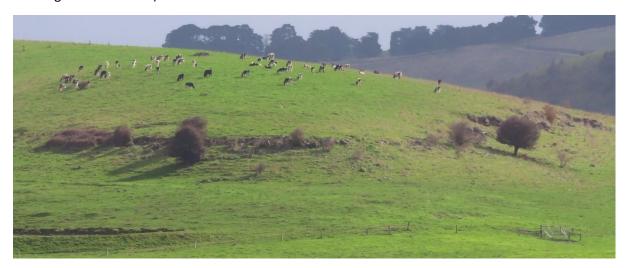
EMERGENT ROCKS ON HILLSIDE

Vegetation on the expanded quarry footprint is pasture grass. There is an area of emergent rocks at the end of the eastern spur about halfway up the hill. There are native raspberries growing amongst the rocks. The area of emergent rocks has been mapped and excluded from the quarry footprint. The area is in close proximity to the extraction limit and a topsoil storage area. (Refer to Site Plan drawing 21-112 sheet 2)

In order to protect against accidental damage, a vegetation protection fence will be installed on the uphill side of the feature. The fence will be installed before works are within 200m on the sensitive site. The fence will consist of high visibility plastic flagging, star pickets and one wire support.
